ACTON TOWN WIDE FACILITY & ELECTRIFICATION STUDY

10 YEAR MASTERPLAN

05 JULY 2023

PREPARED FOR
TOWN OF ACTON

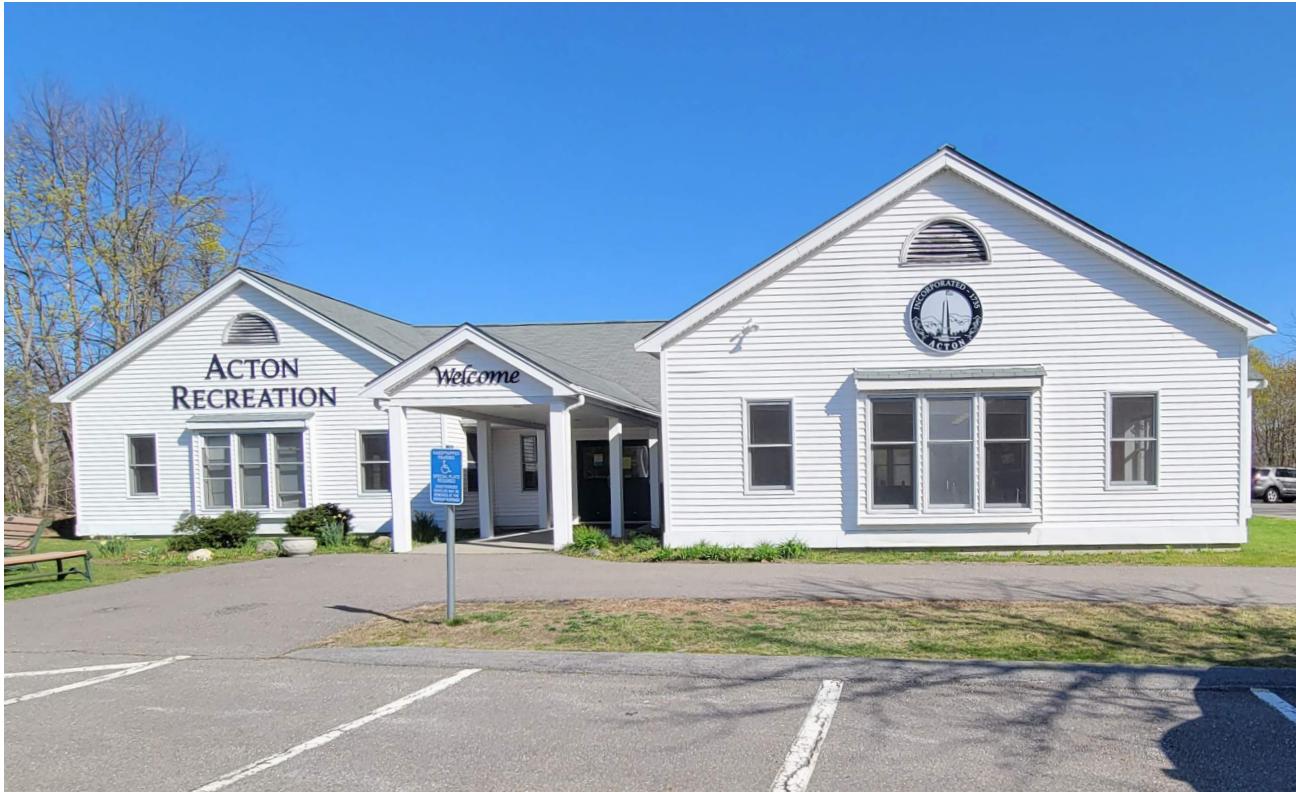
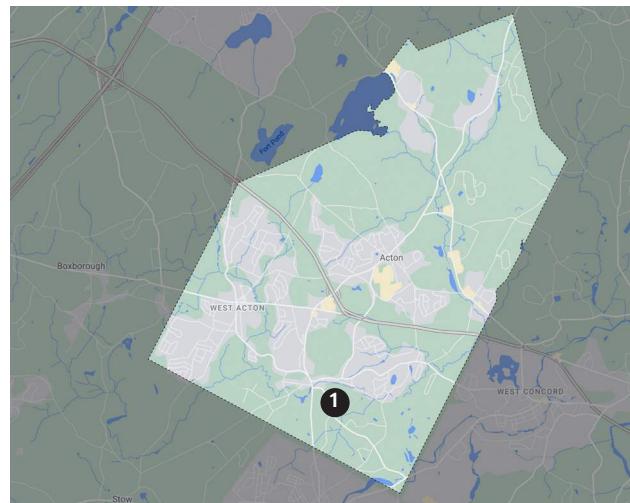
Recreation Center

STRUCTURE	Concrete foundation, lally columns, wood frame floor and roof. No structural issues evident.
EXTERIOR WALLS	Vinyl siding, some areas of damage evident. Mold growth from water running down exterior walls evident in multiple areas. Existing insulation is 5 1/2" R-19 fiberglass insulation. Metal base trim damaged in some areas.
EXTERIOR OPENINGS	Single-pane wood windows with screen units. Exterior motorized doors installed in 2013. Attic vent louvers at gable ends, need paint and maintenance.
ROOFING AND RAINWATER MANAGEMENT	Roof is original to building, asphalt shingle. Metal gutters and downspouts, some areas of damage, some areas not functioning as designed. No lightning protection system, building has been reported to have been hit multiple times. Minimal insulation reported at attic level.
STAIRS AND VERTICAL CIRCULATION	The building is one floor that is publicly accessible with a basement. Access to the basement is available only from a bulkhead outside of the building.

If the work is desired to be phased, more pressing exterior work (roof, windows) could precede the interior and mechanical renovation phases.

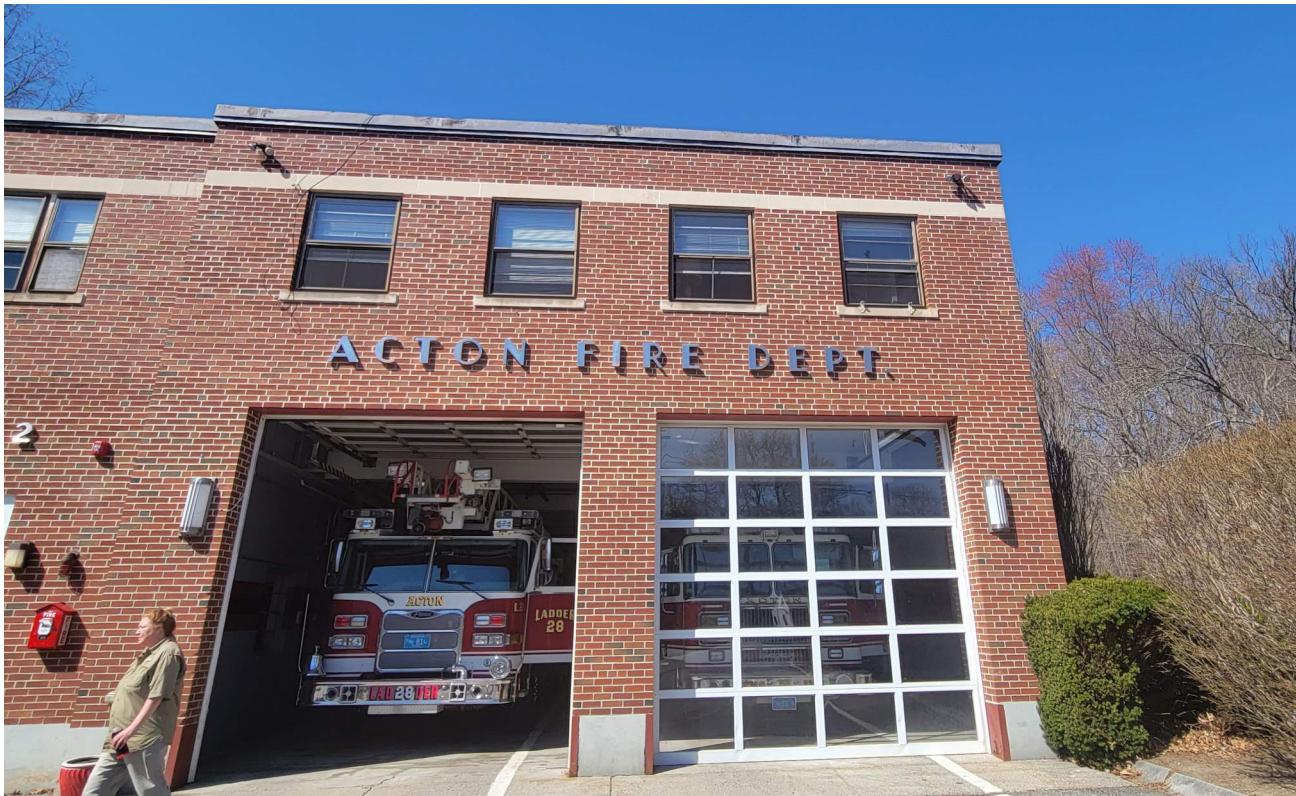
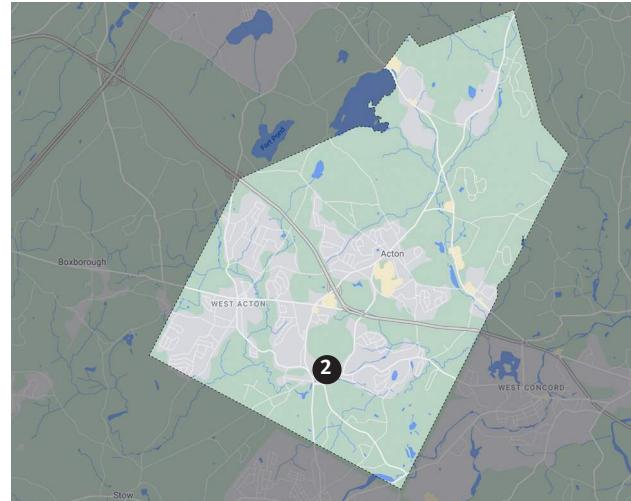
South Fire

Architectural conditions are likely going to drive the need to further invest in the building prior to the anticipated end of life of the mechanical system. The roof is 26 years old and windows are original to the building - 62 years old. Both are in need of replacement within the immediate future. The interiors of the building are in generally good condition, although asbestos has not been abated and the restroom is in need of a gut renovation. Accommodating new gendered code compliant restrooms with new showers may be challenging in the given footprint. The mechanical systems should have approximately 20+ years of life on the lower level system and 11 years of life on the upper level system left. This would put them being replaced after the 2030 goal for complete electrification. Electrification will require significant exterior vertical wall upgrades. Therefore, it is recommended that electrification may want to be considered as a new build scenario and reviewed with immediate capital projects to determine most cost effective solution.

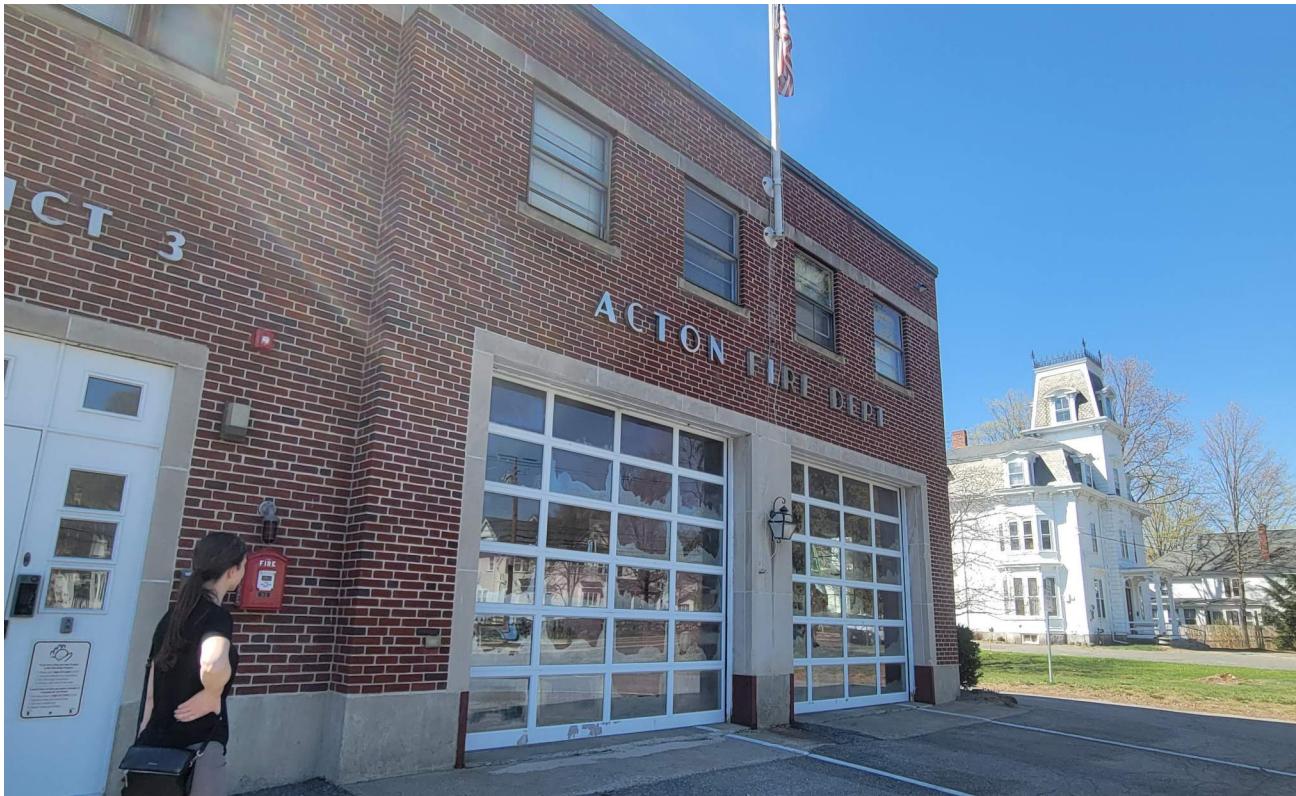
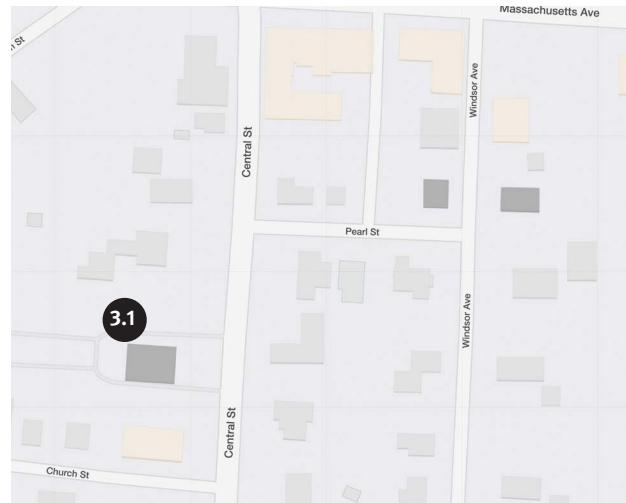
West Fire

Architectural conditions and programmatic upgrades are likely going to drive the need to further invest in the building prior to the anticipated end of life of the mechanical system. The roof is 26 years old and windows are original to the building - 62 years old. Both are in need of replacement within the immediate future. The interiors of the building are in generally good condition, although asbestos has not been abated and the restroom is in need of a gut renovation. Accommodating new gendered code compliant restrooms with new showers may be challenging in the given footprint. The mechanical systems should have approximately 20+ years of life on the lower level system and 11 years of life on the upper level system left. This would put them being replaced after the 2030 goal for complete electrification. Electrification will require significant exterior vertical wall upgrades. Therefore, it is recommended that electrification may want to be considered as a new build scenario and reviewed with immediate capital projects to determine most cost effective solution.

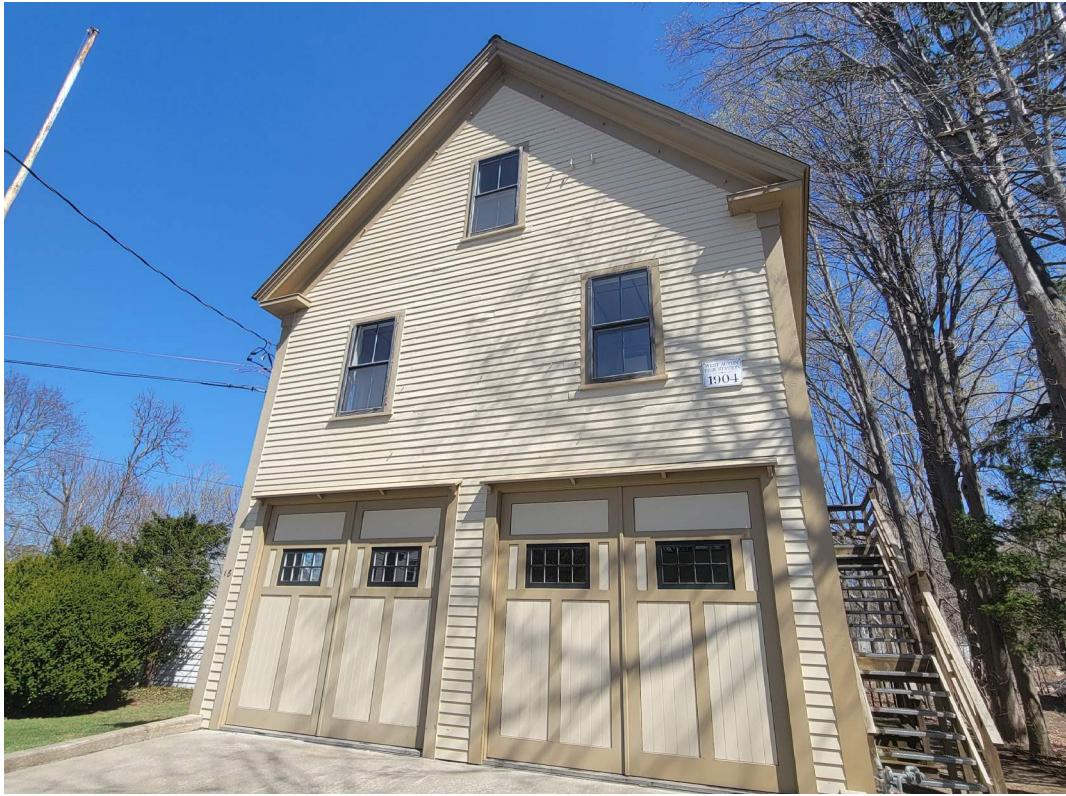
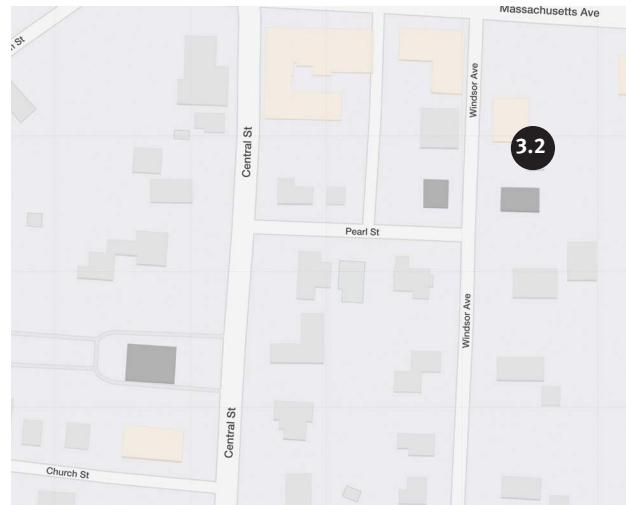
Windsor Building

The building is currently vacant with little use outside of book storage and the occasional book sale. The building will need a significant renovation to bring up to condition for everyday use. It is recommended that the building be electrified at the time of this renovation.

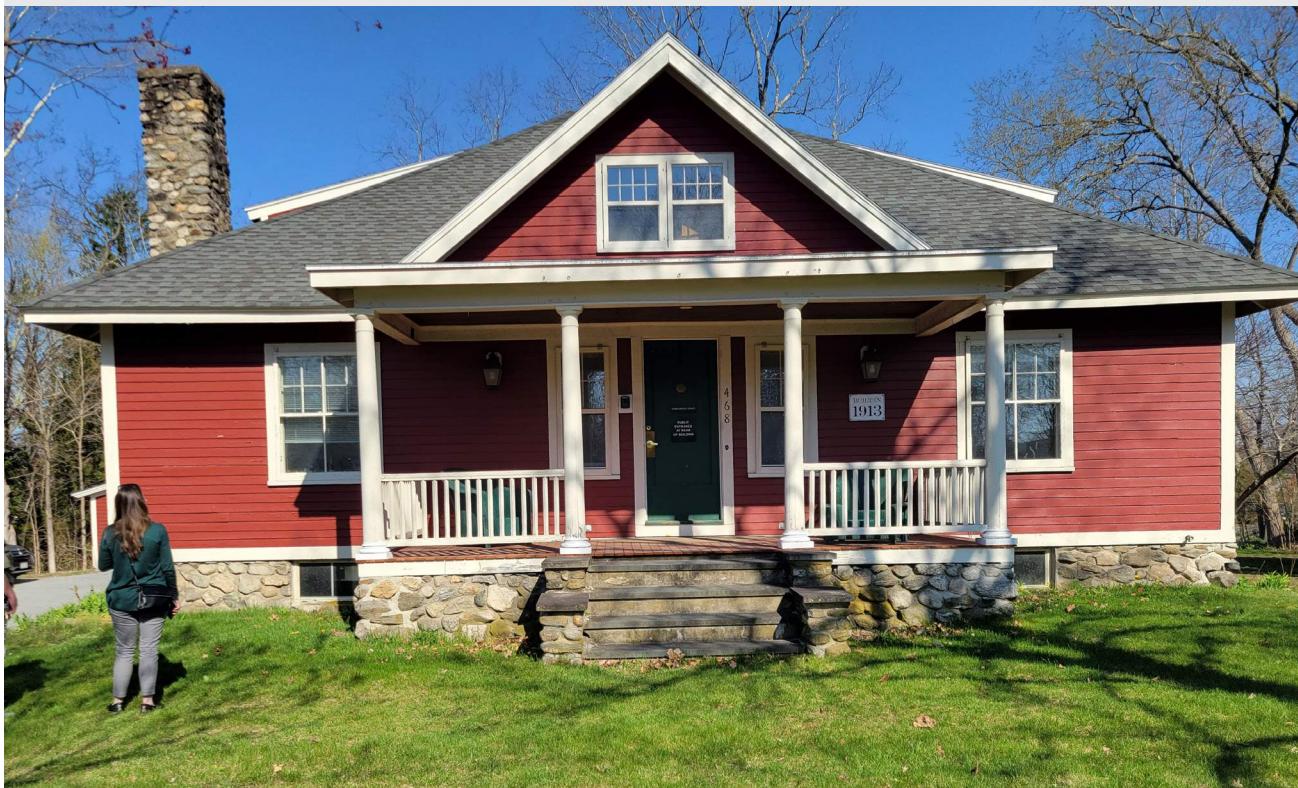
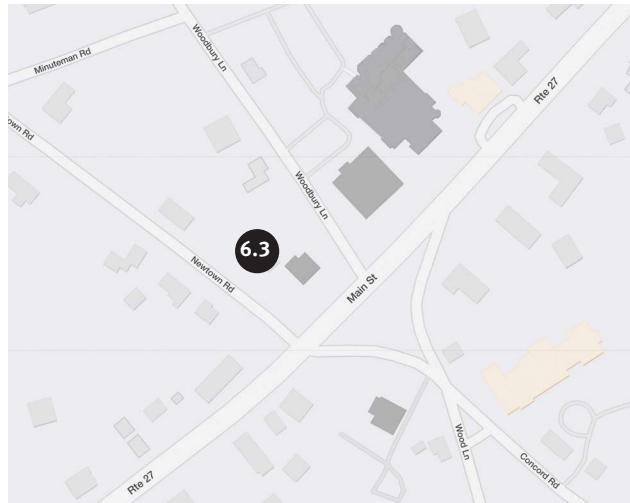
Red House

Both the mechanical systems and the roof are nearing the end of their useful life. A comprehensive envelope and mechanical system project should be completed together. While the electrical service is not in need of immediate action it will need to be done at the time of mechanical system replacement as that replacement should be an electrified system.

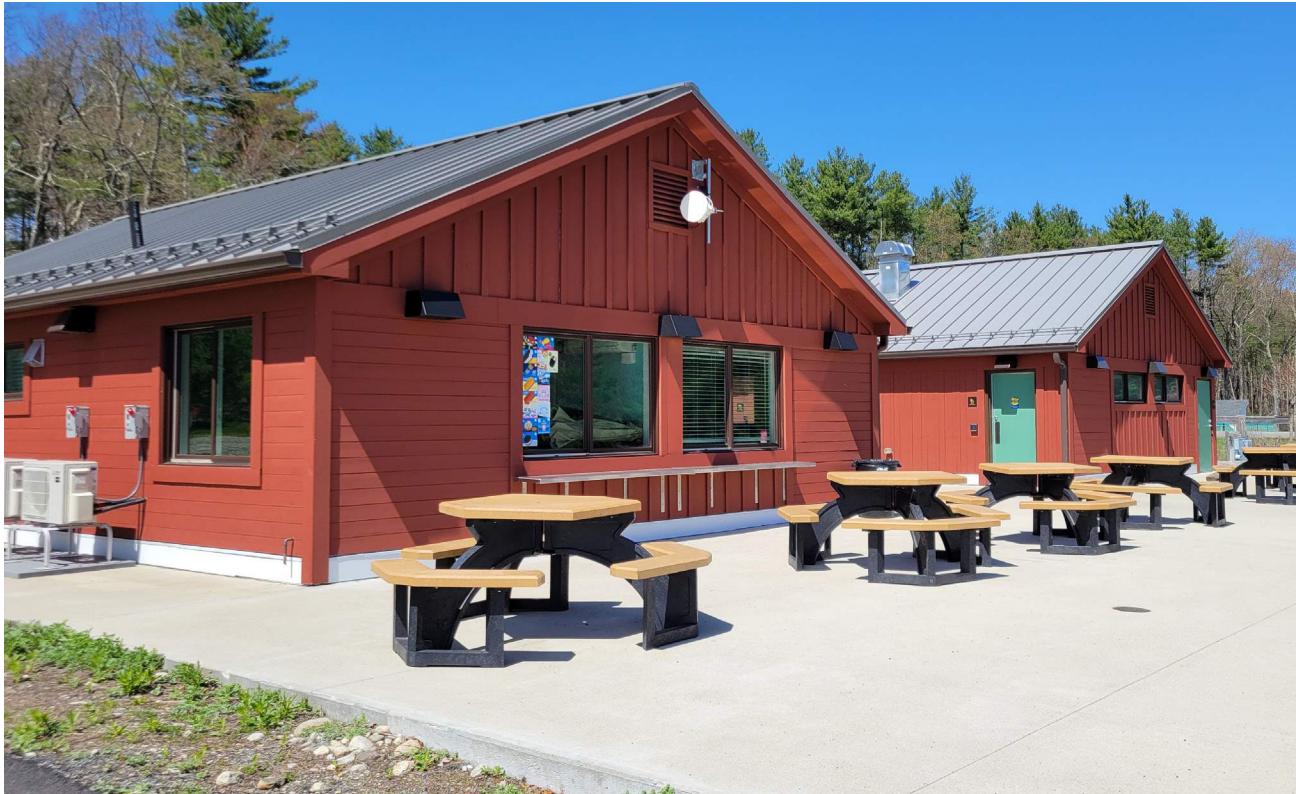
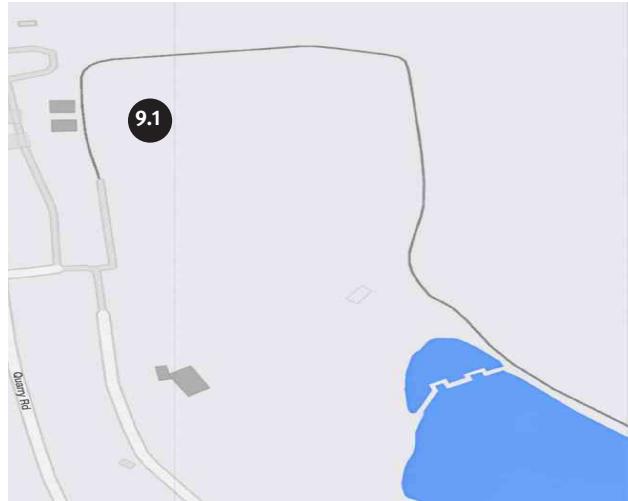
NARA Sports Pavilion

APPEARANCE	Evidence of graffiti removal- frequent painting may be necessary to maintain the appearance of buildings.
HISTORIC DISTRICT CONSIDERATIONS	This building is not in a Historic District nor is it on the National Register.
