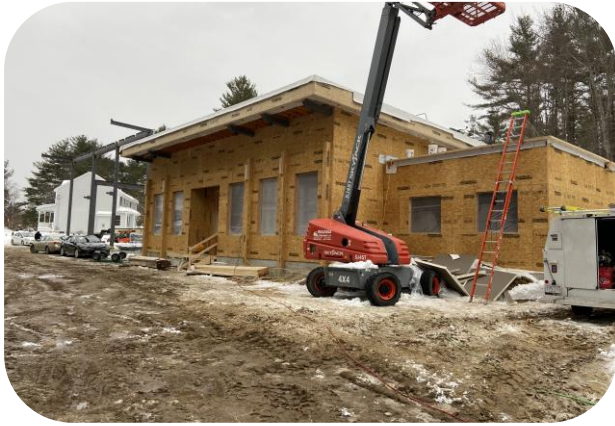
Overview of wood construction from southeast

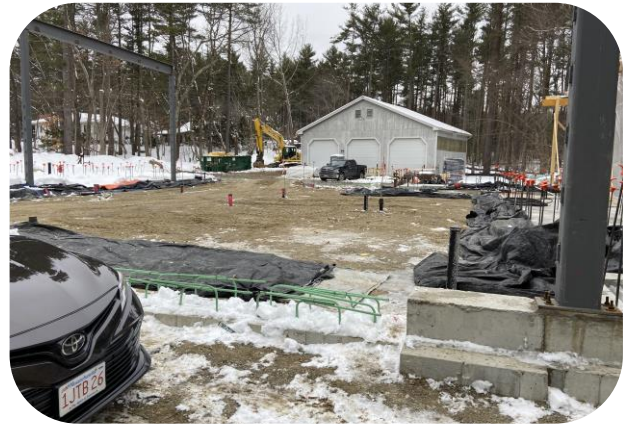
Snow removed from apparatus bay

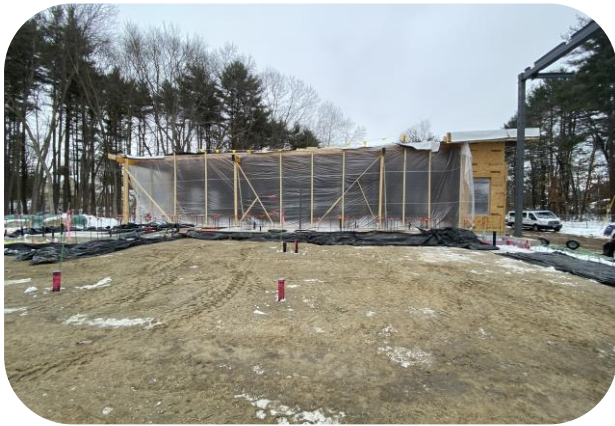
Overview of building from west side

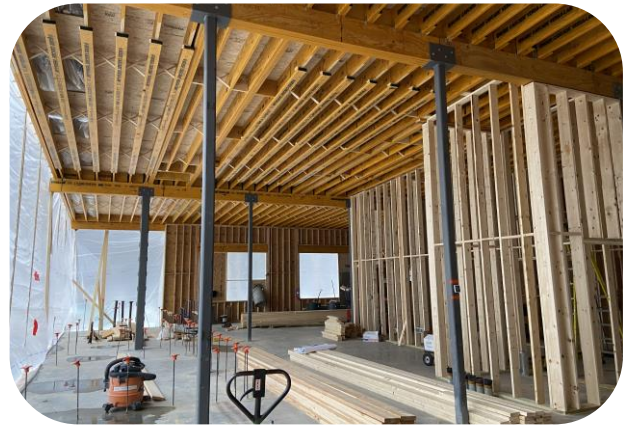
Interior wood framing and LVL corrective action

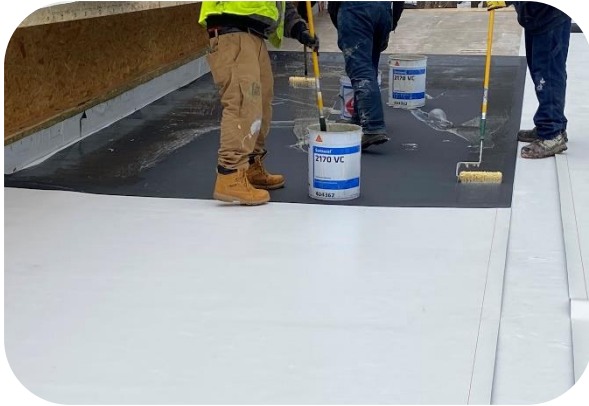
Installation of waterproofing in low roof area

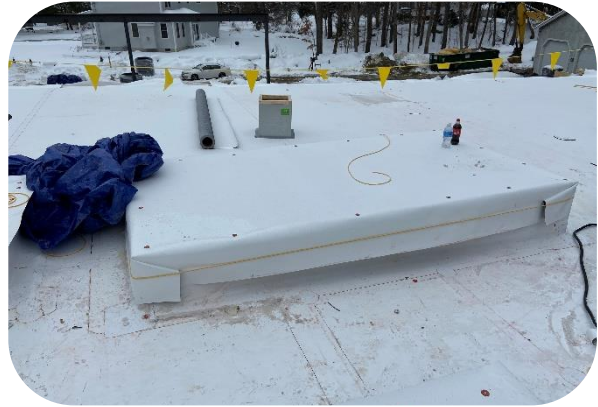
Waterproofing and mechanical curb installed on living area

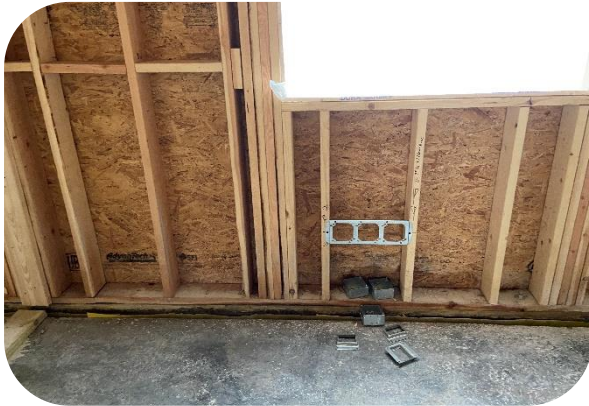
Electrical rough work on east side of building

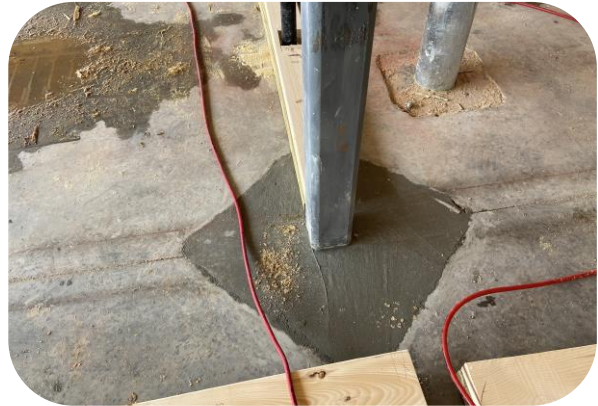
Concrete placed in column box
