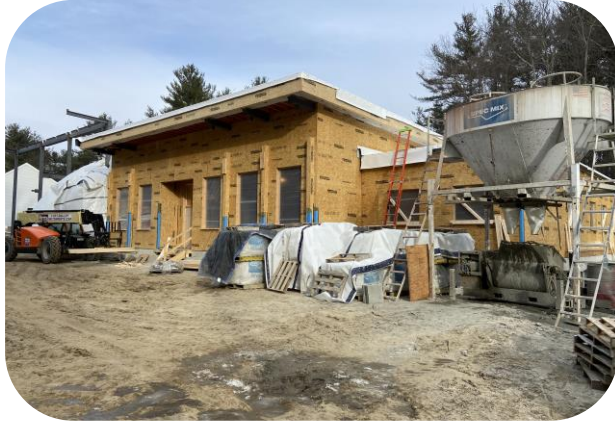
Overview of east side

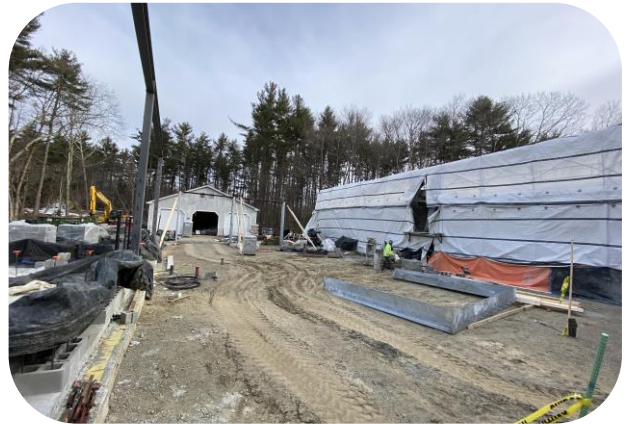
Overview of apparatus bay area

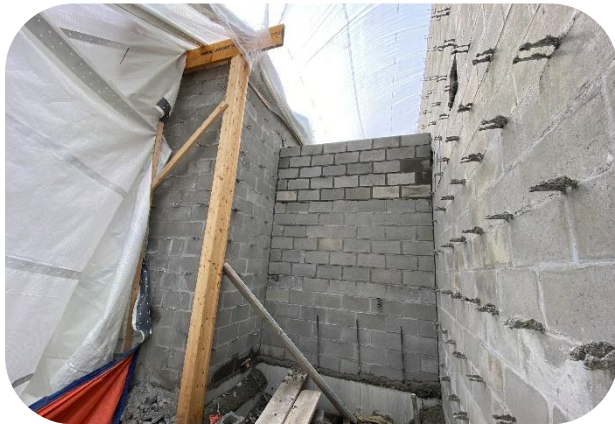
Northern exterior wall of electrical sub room between Line 6.5 and 5.

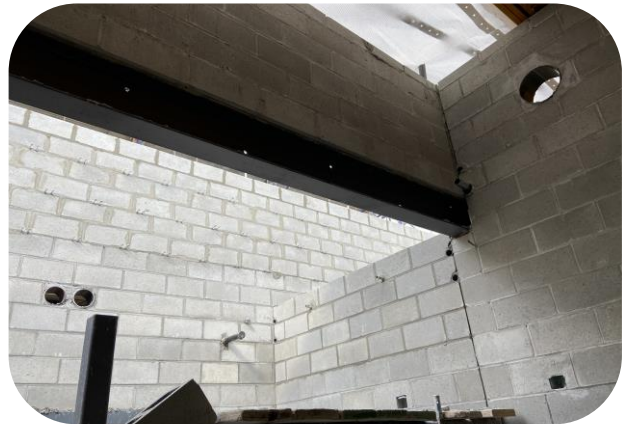
Steel beam header at gear room looking west to Line 5. Holes drilled in beam for ledger installation per structural engineer direction

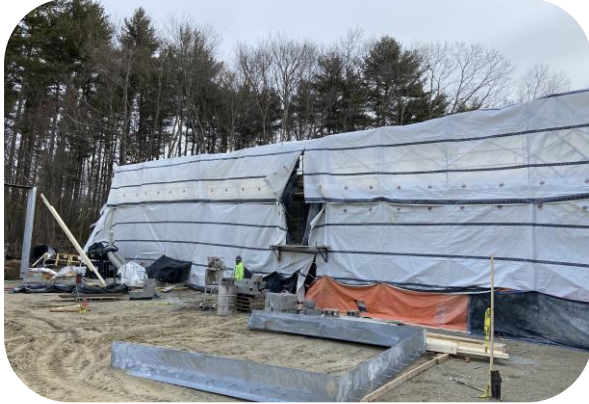
Masonry apparatus bay door frame

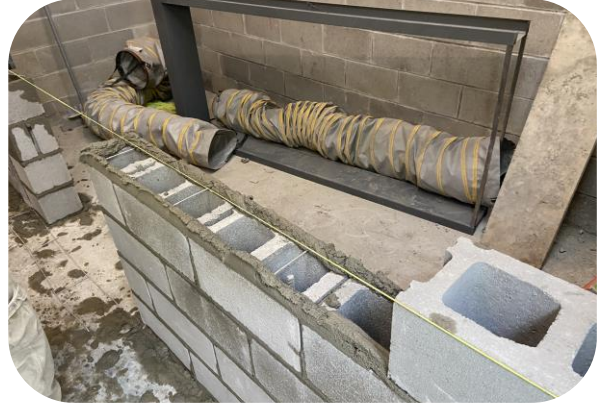
Typical construction of interior masonry wall

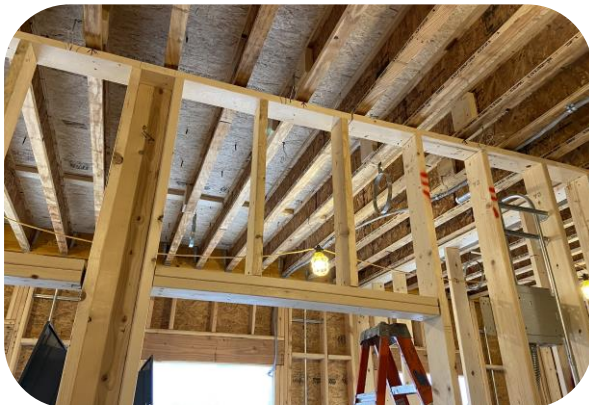
HVAC hanger installed in low roof area

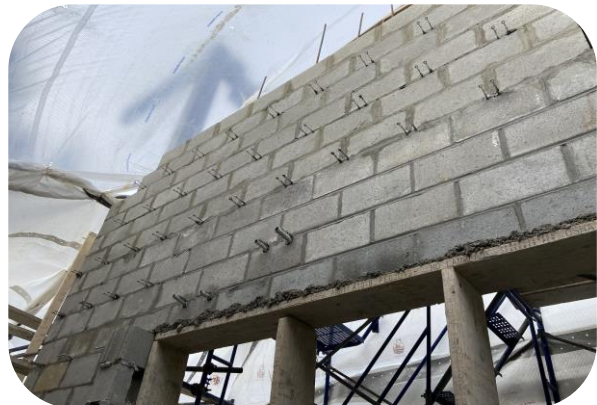
Line 5 masonry installation
