PMA Consultants

NAFS Photo Log 04.01.2021

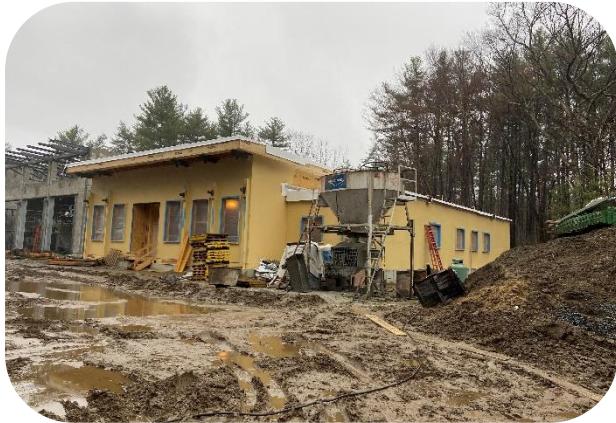
Overview of east side

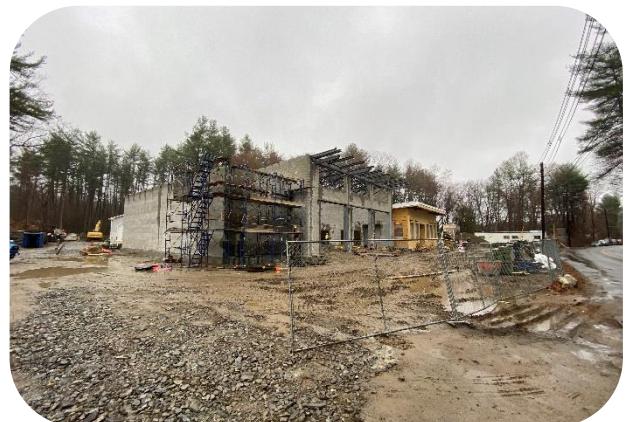
Overview of building from southwest side of site

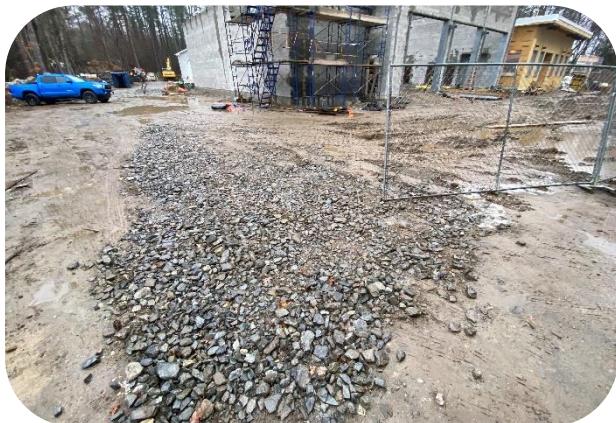
Corrected rip rap at southwest construction entrance

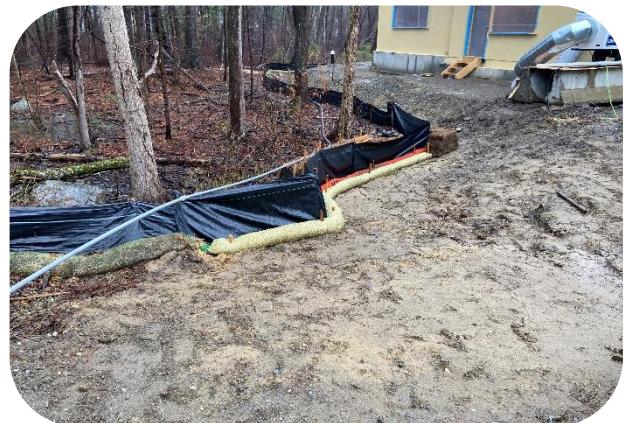
Corrected erosion and sediment control near north side of building

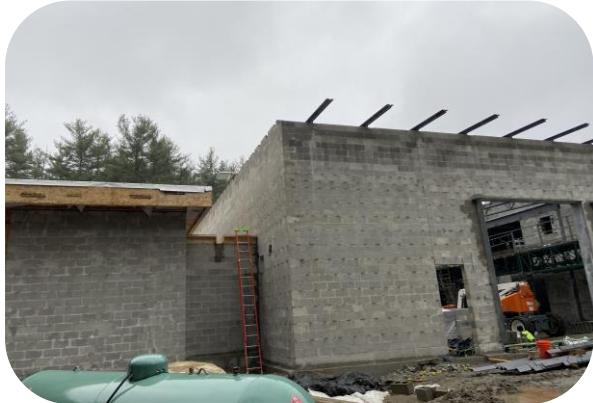
North side of apparatus bay

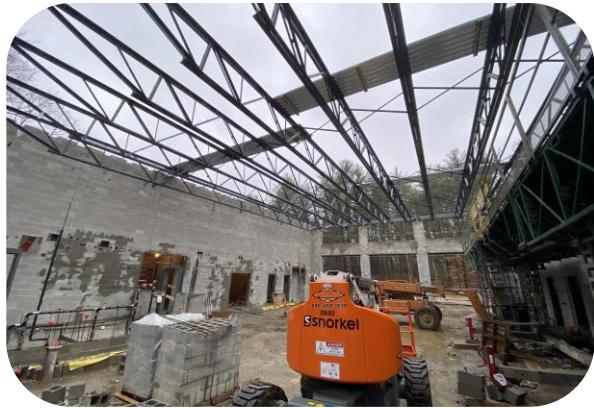
Steel roof joists in apparatus bay looking south from north side

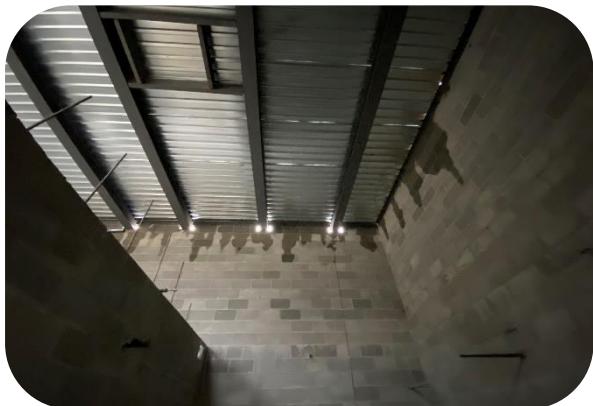
Northwest side of western mezzanine

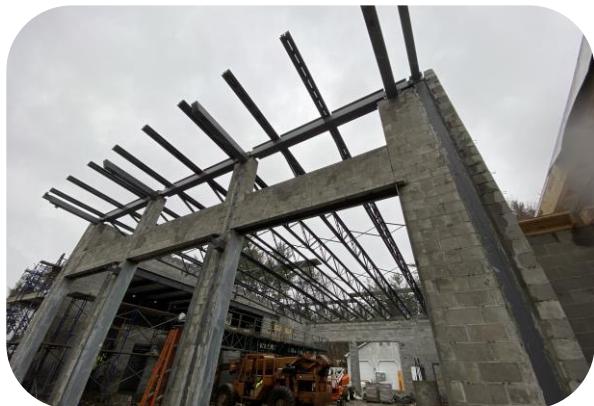
Steel roof joists in apparatus bay looking north from south side

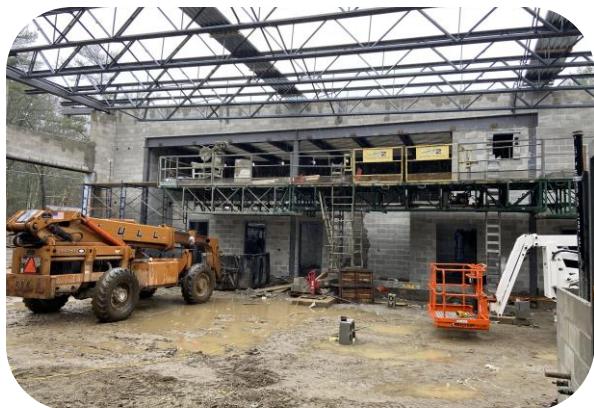
Western mezzanine

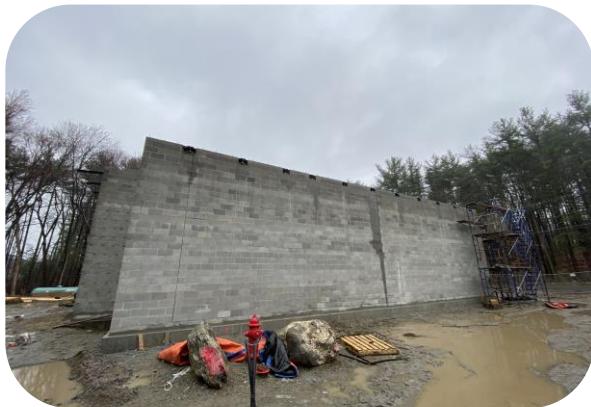
West side of building

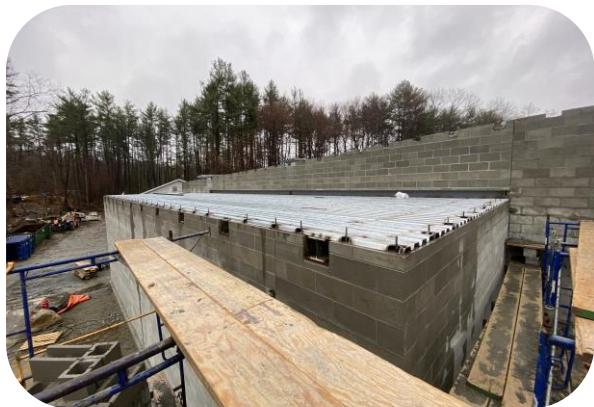
Metal roof decking on western mezzanine

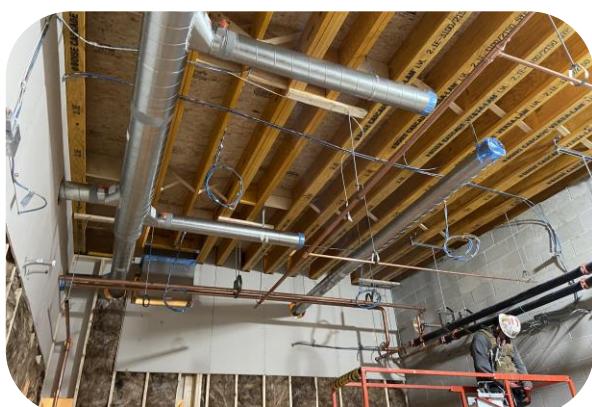
MEP in fitness room

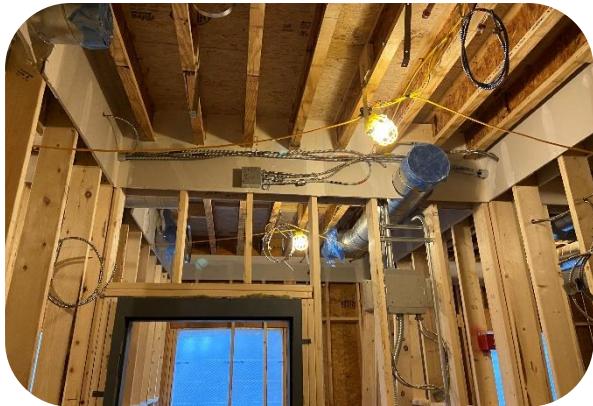
HVAC and electrical in bunk areas

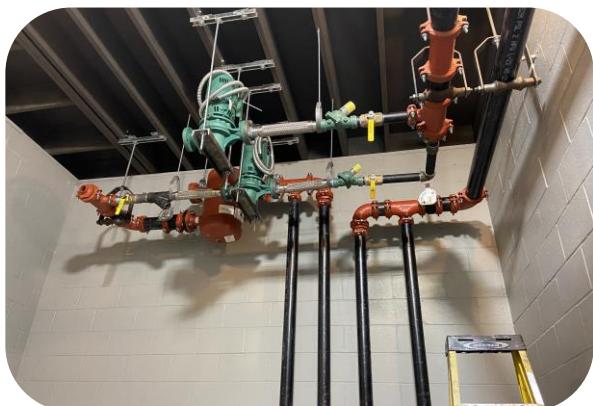
Geothermal mechanical in mechanical room

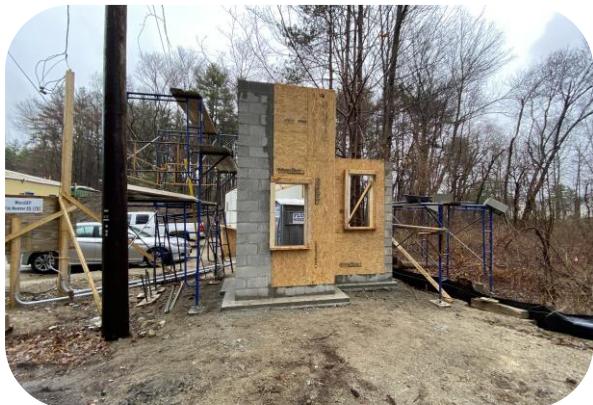
Mock up at job site trailer

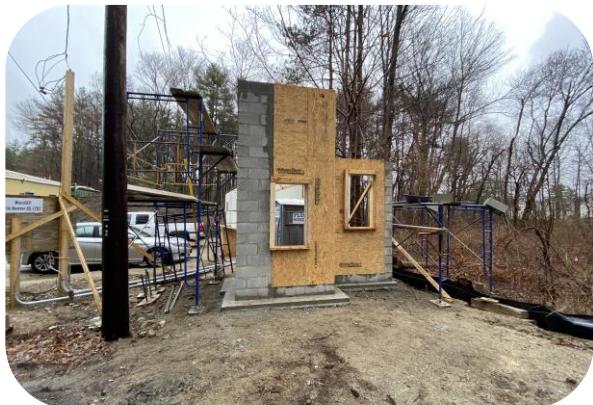
Mock up at job site trailer
