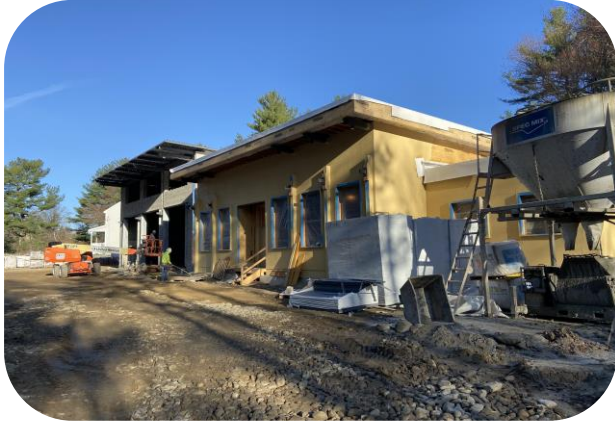
Overview of east side

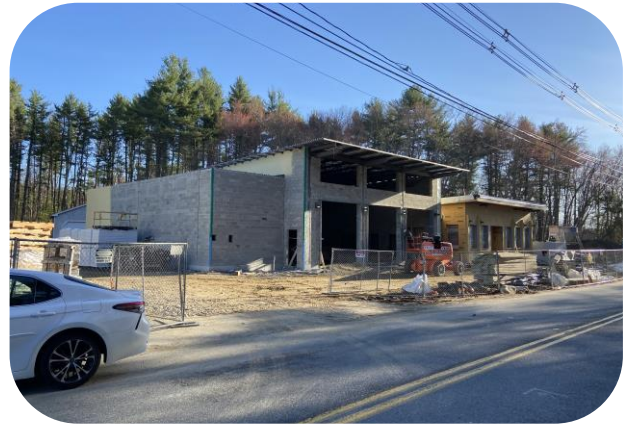
Overview of building from southwest side of site

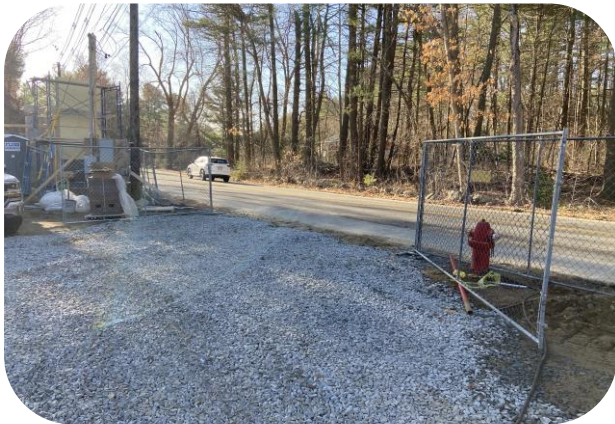
Fencing and crushed stone at southeast construction entrance

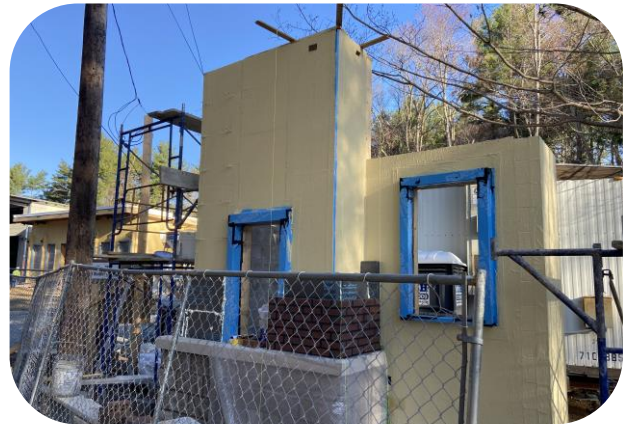
AVB and masonry facade installation at mock-up

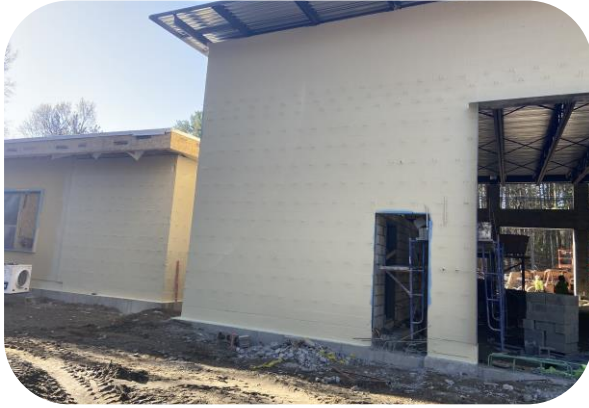
North side of apparatus bay with installed AVB

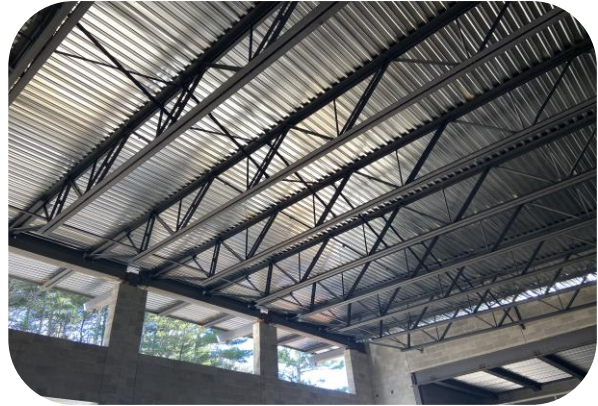
Steel roof joists in apparatus bay looking southwest

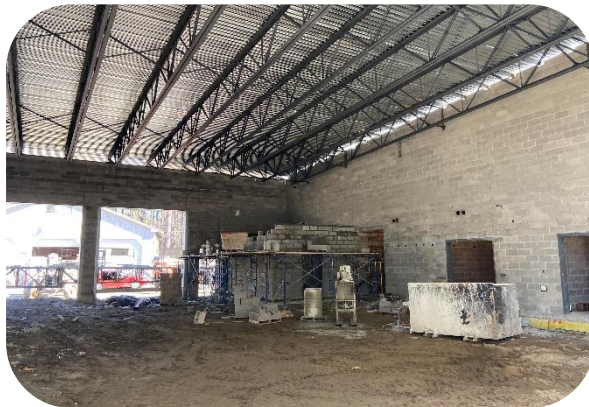
Masonry construction in dirty laundry room

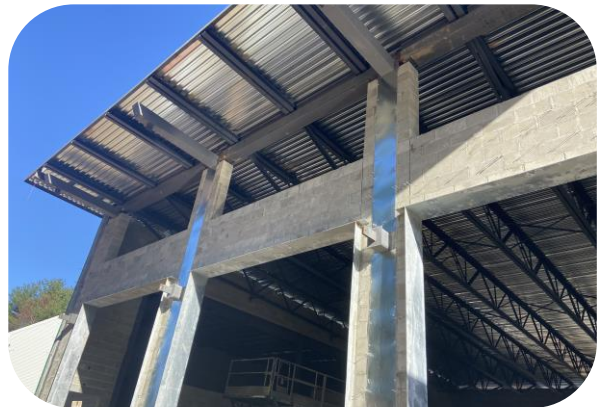
Sheet metal installed at steel columns on south face of apparatus bay for AVB preparation.

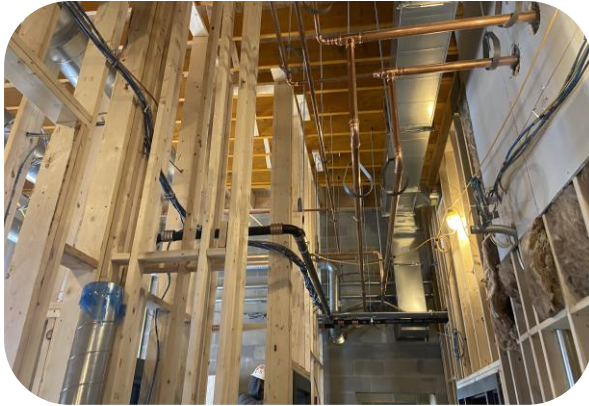
MEP rough-ins

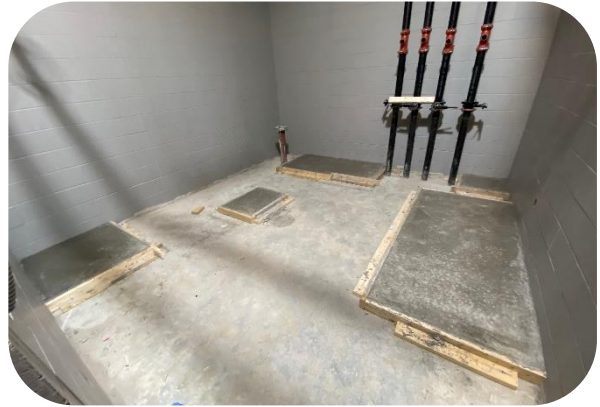
Mechanical pads installed in mechanical room

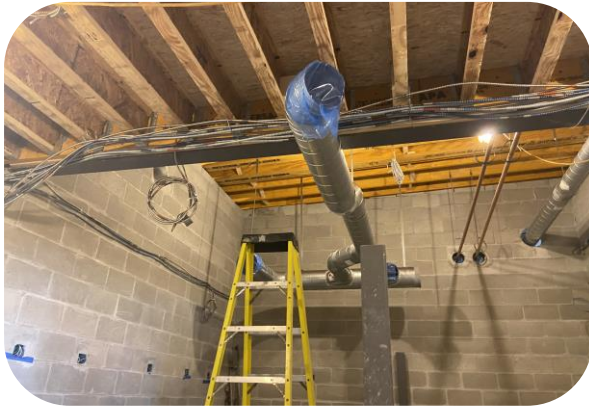
MEP rough-ins in gear room

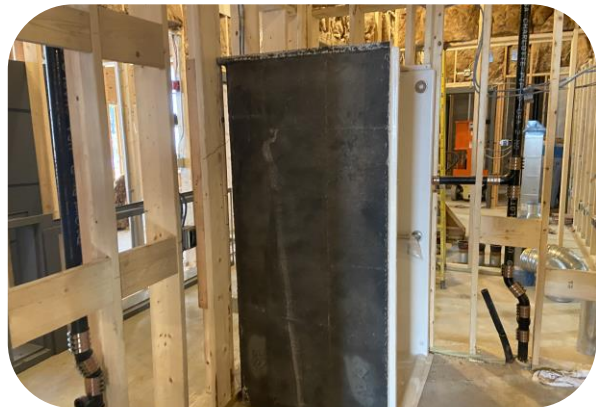
Shower installation
