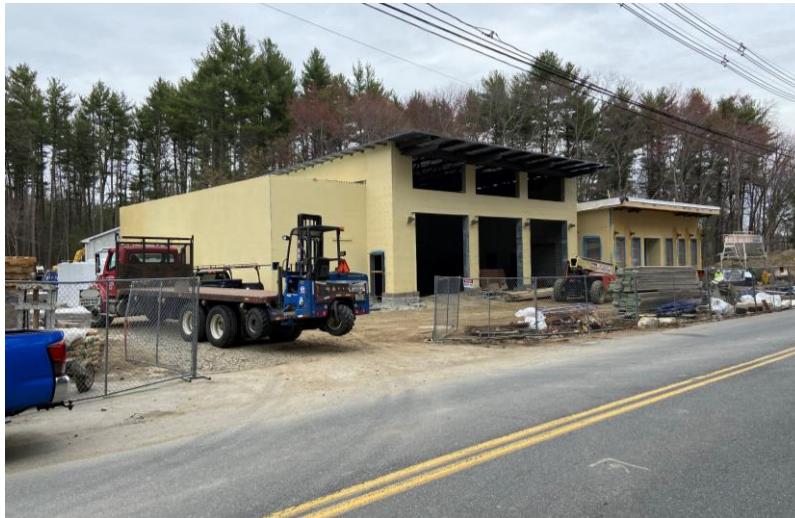
Overview of site from southwest

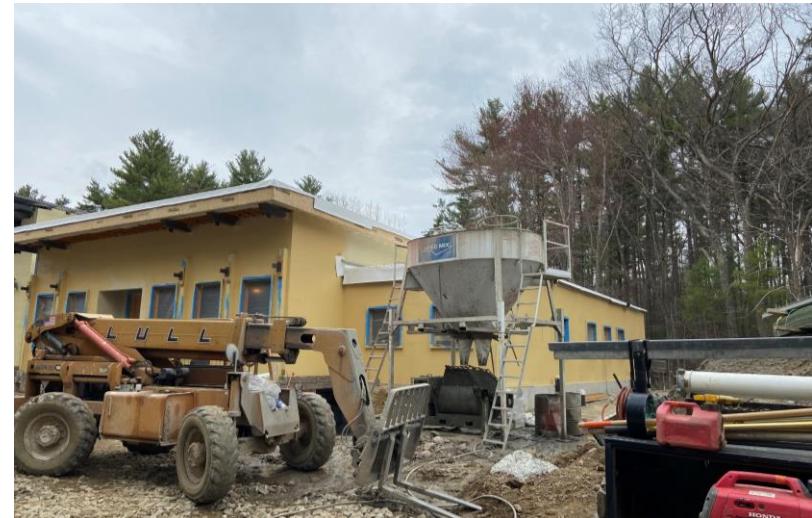
Overview of east side of building

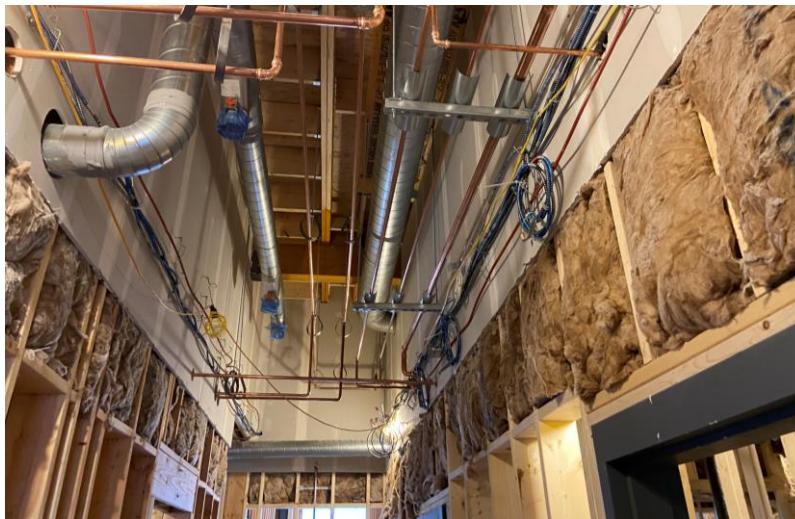
MEP rough-ins on east side

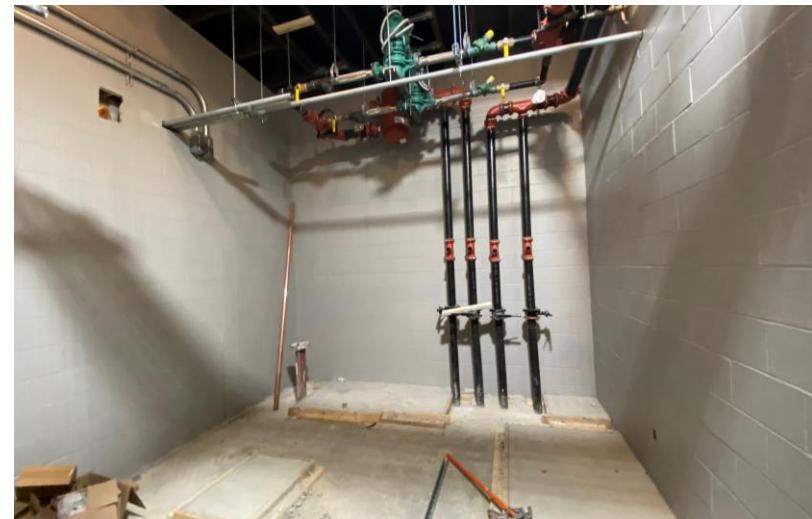
Mechanical room

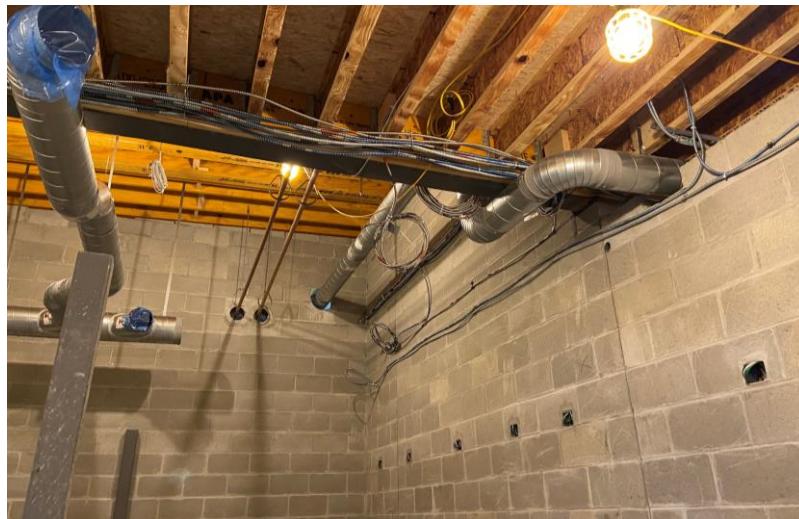
MEP rough-ins at gear room

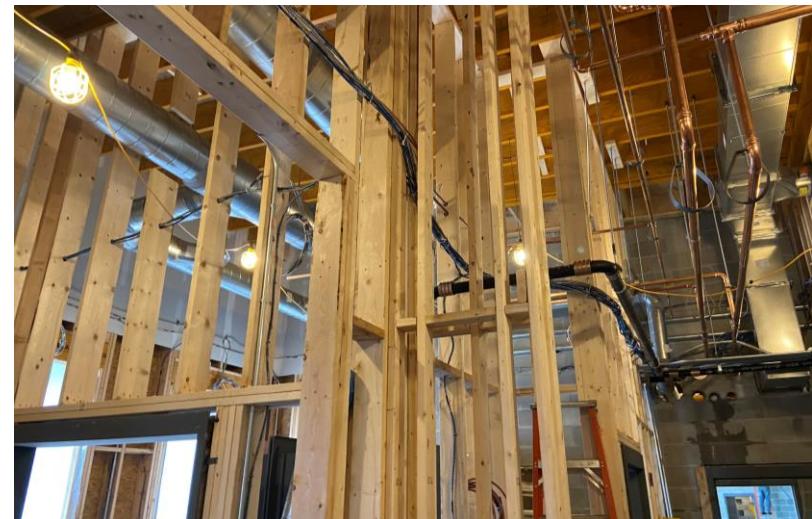
MEP rough-ins on east side

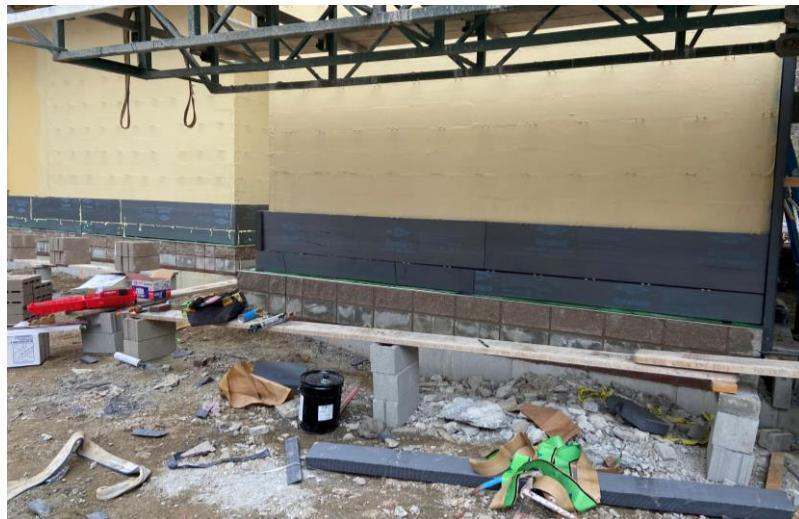
Façade installation on north side

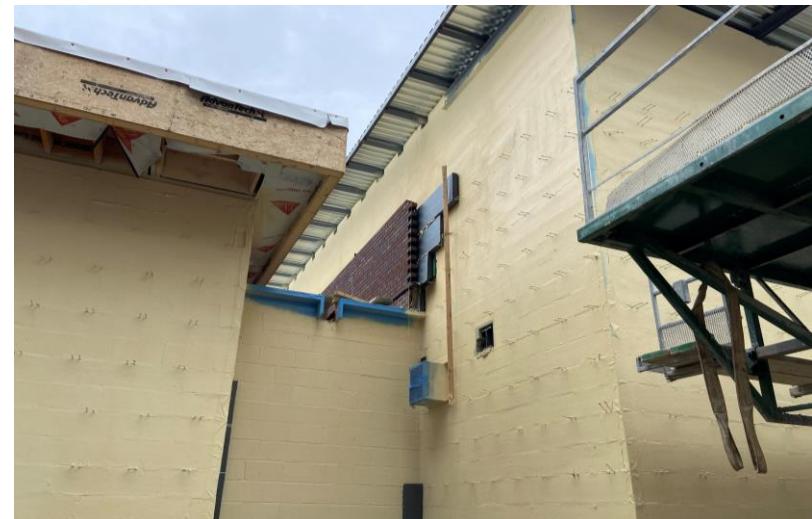
Façade installation at transitional low roof

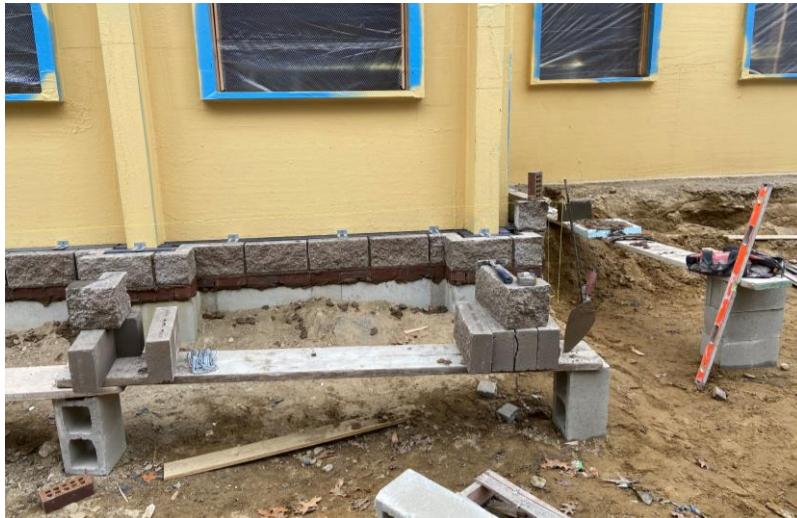
Façade installation on south side

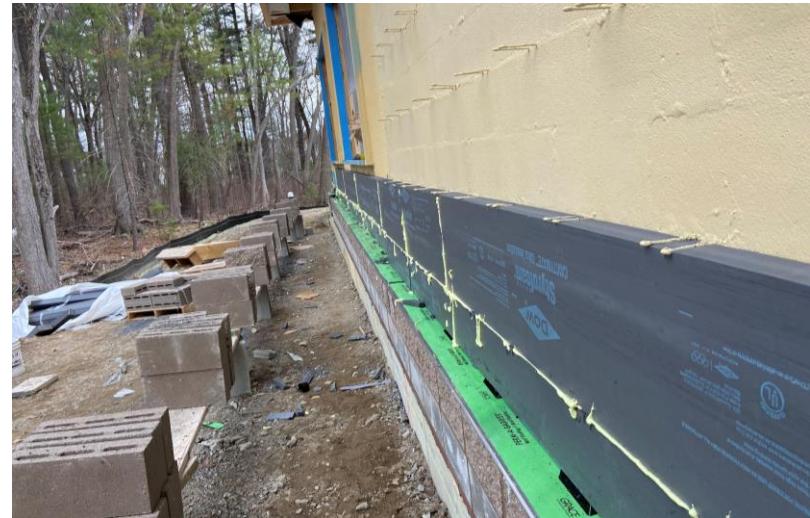
Flashing installed on north side

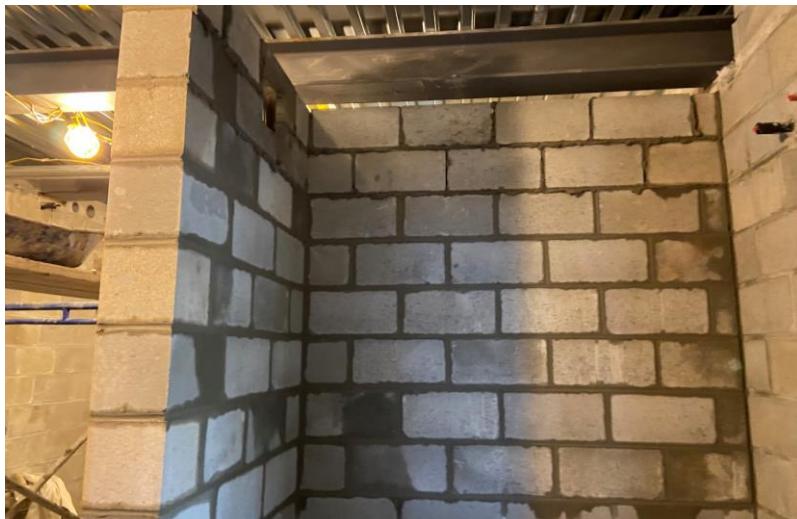
Interior wall in dirty laundry room

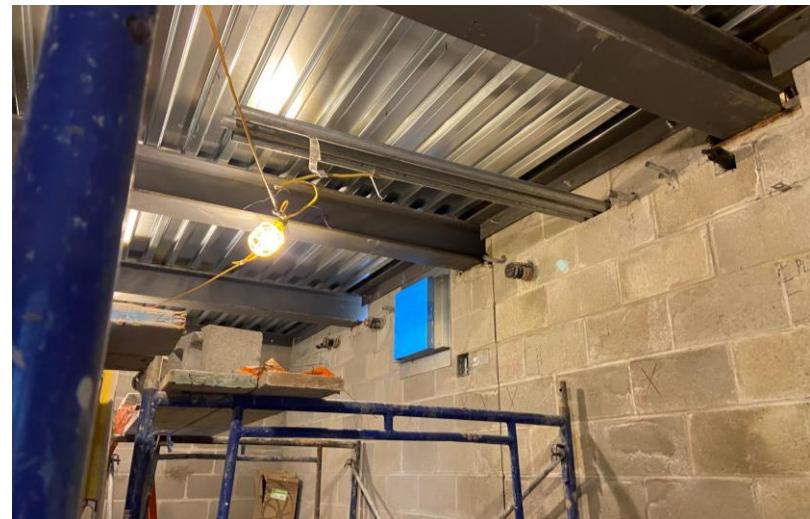
Metal deck roof installed at dirty laundry room

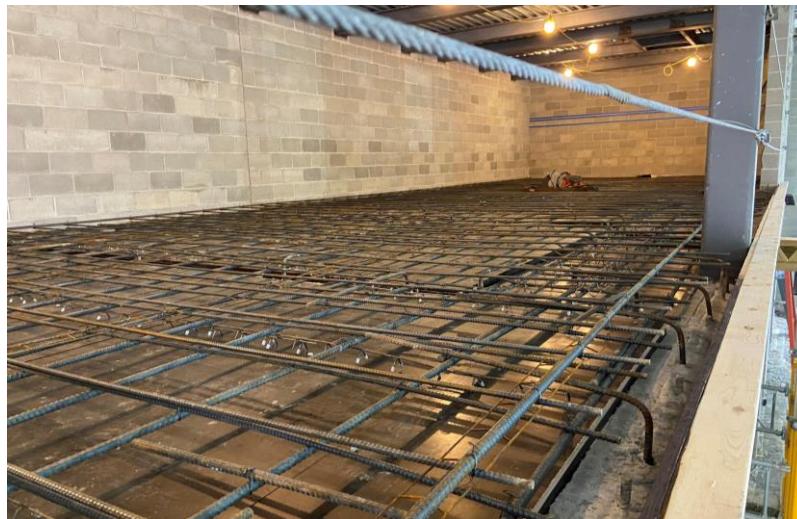
Reinforcing installation for mezzanine slab

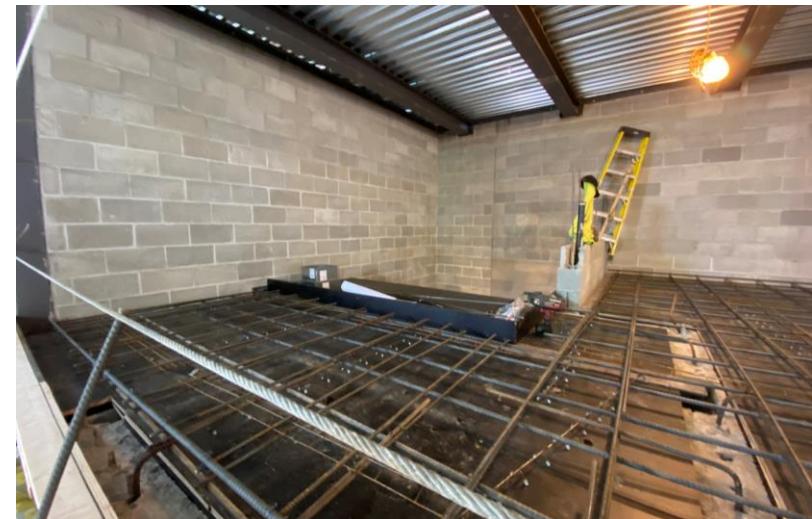
Reinforcing installation for mezzanine slab looking towards south stairs

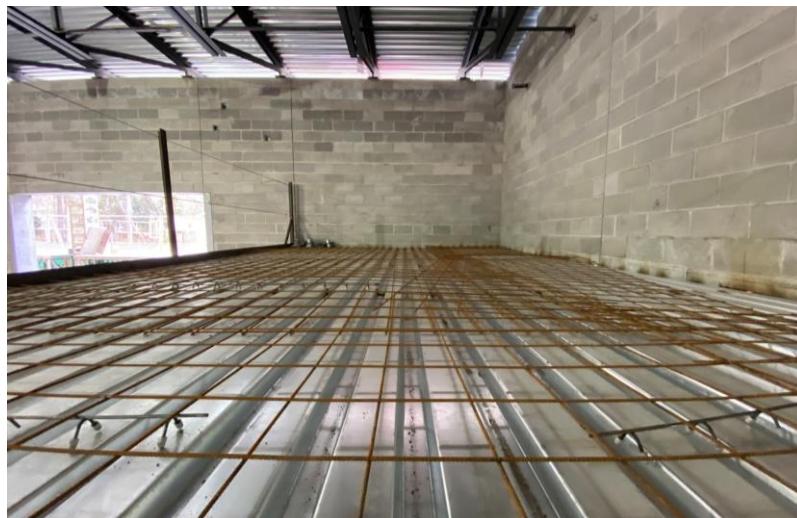
Reinforcing installation for dirty laundry roof

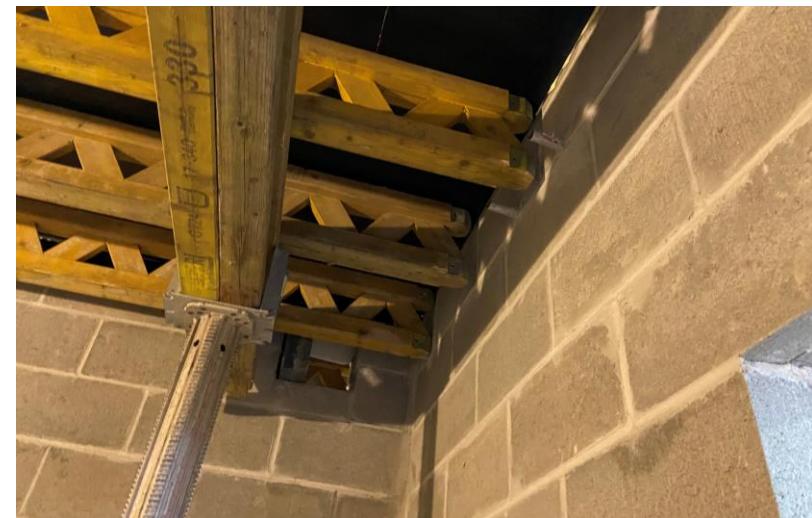
Typical shoring underside for mezzanine slab
