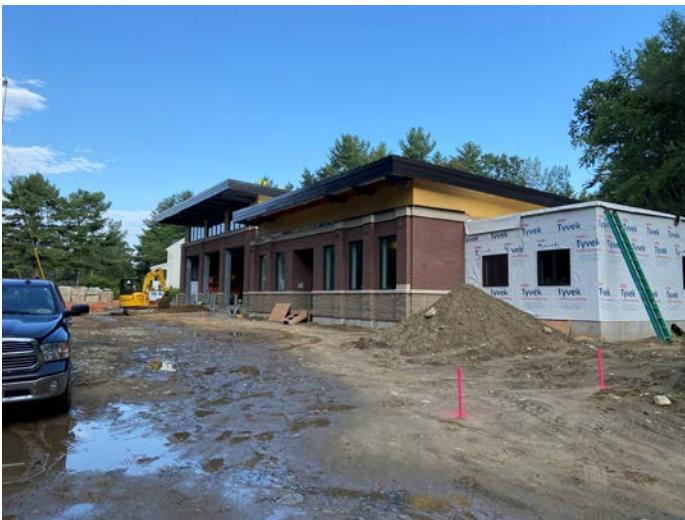
Overview of building from southeast

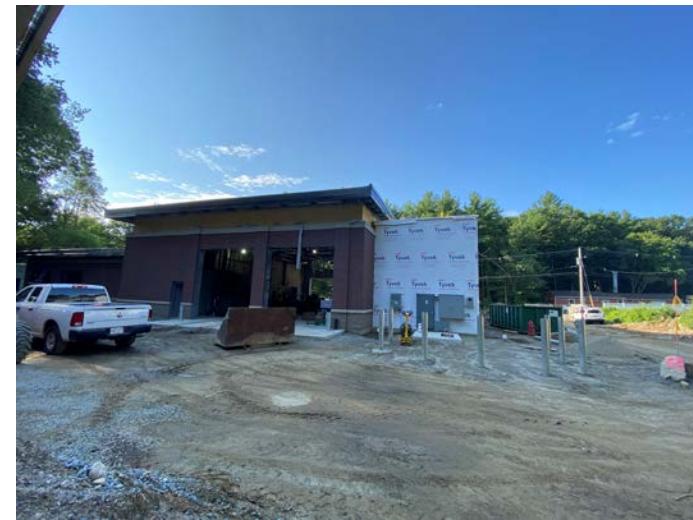
Overview of building from north

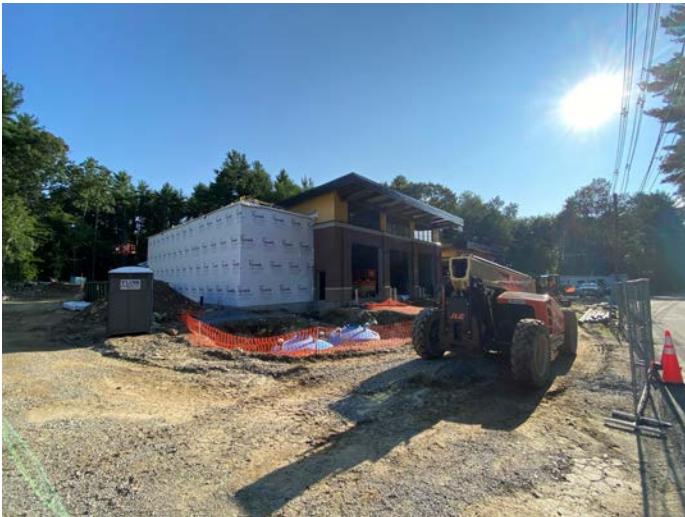
Overview of building from southwest

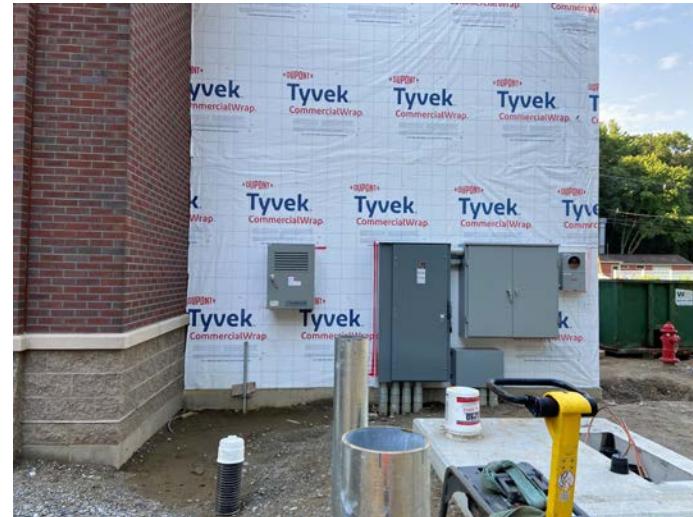
Installation of exterior electrical cabinets

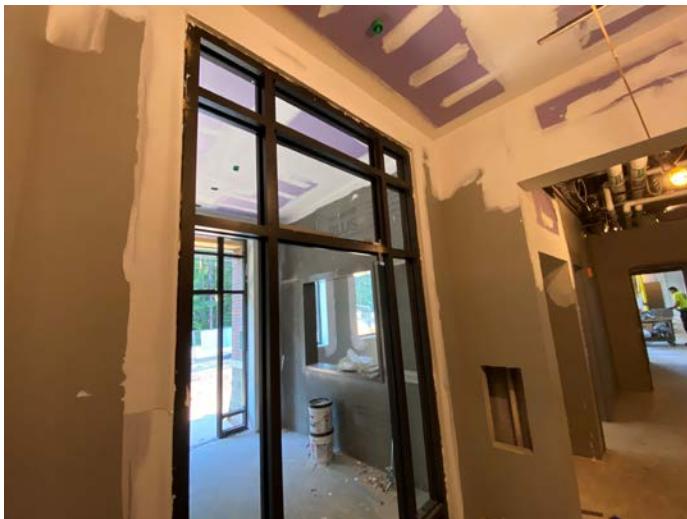
Drywall and frames installed at vestibule

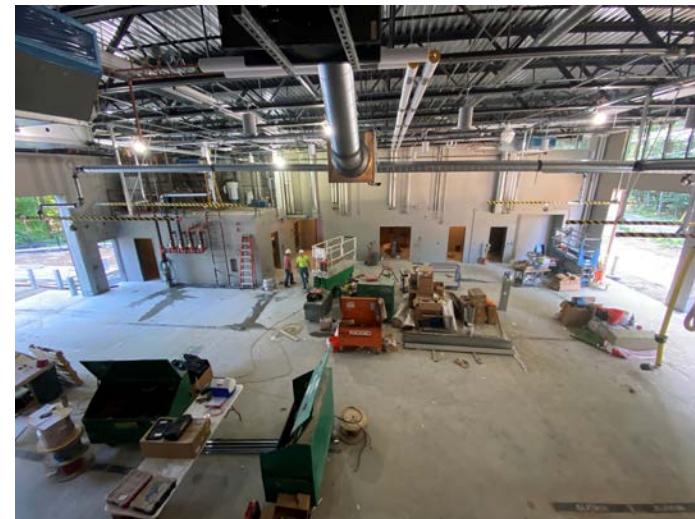
Overview of apparatus bay from mezzanine

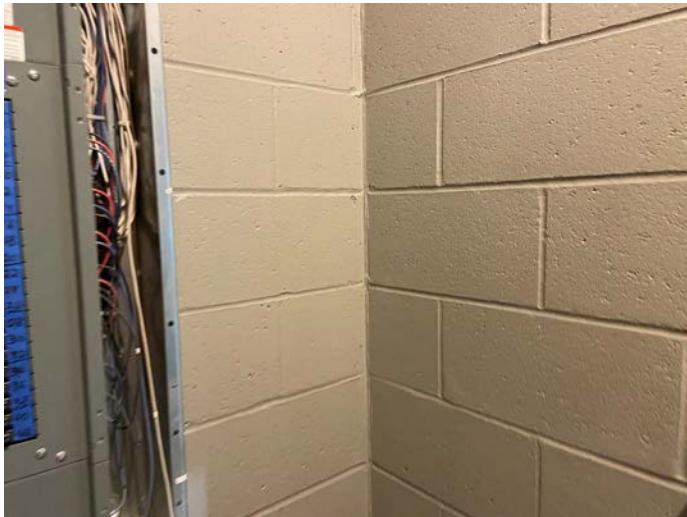
Typical interior sealant installed

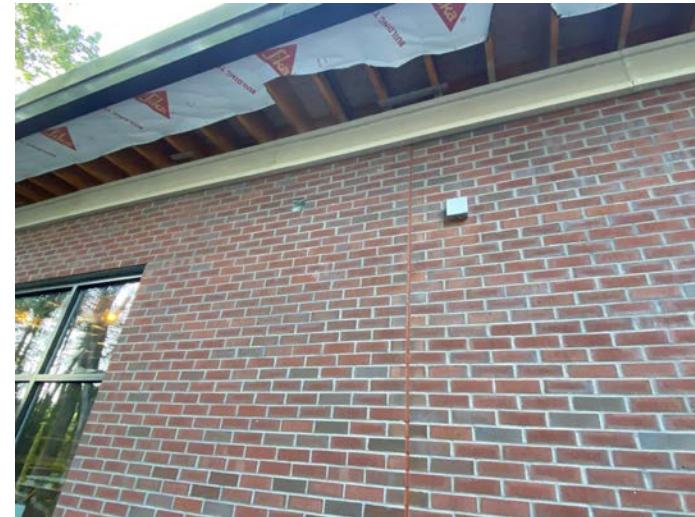
Typical exterior sealant installed

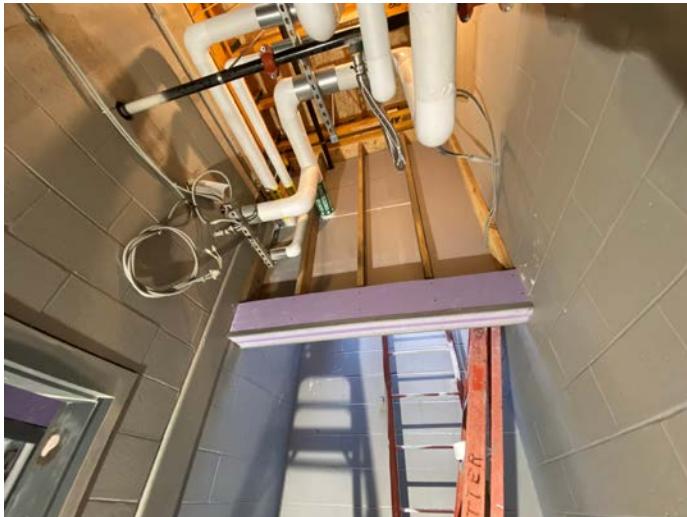
Soffit at eastern roof access ladder

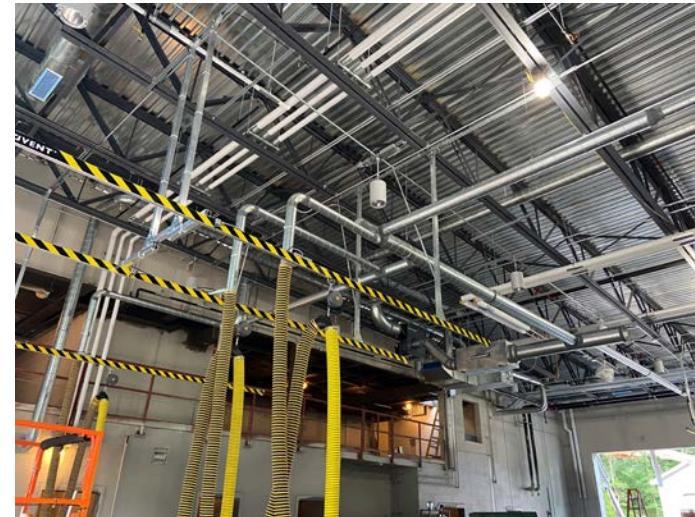
Vehicle exhaust system installation

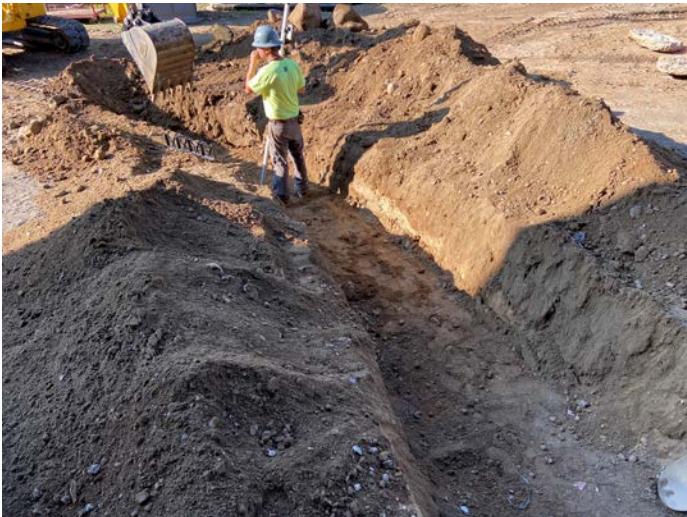
Trench excavation for fire alarm/telecom/IT conduits on south side (Part of PR#009)

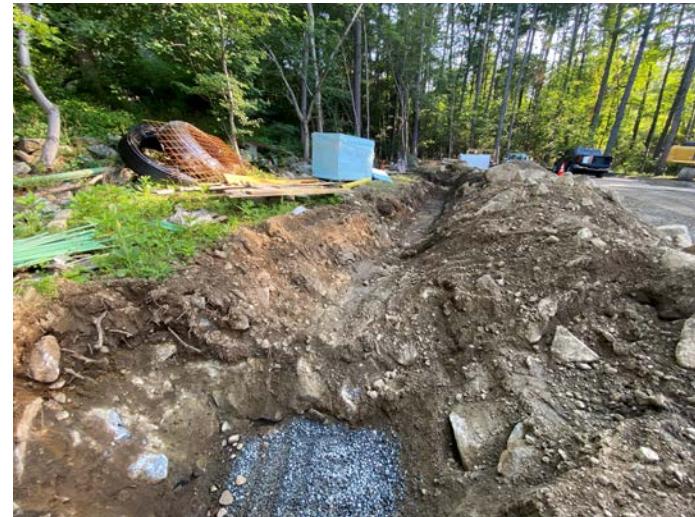
Excavation for north parking lot site lighting and conduits
