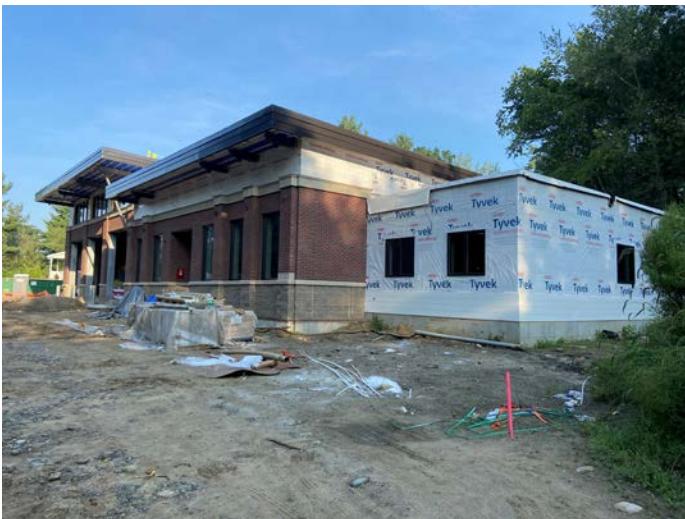
Overview of building from southeast

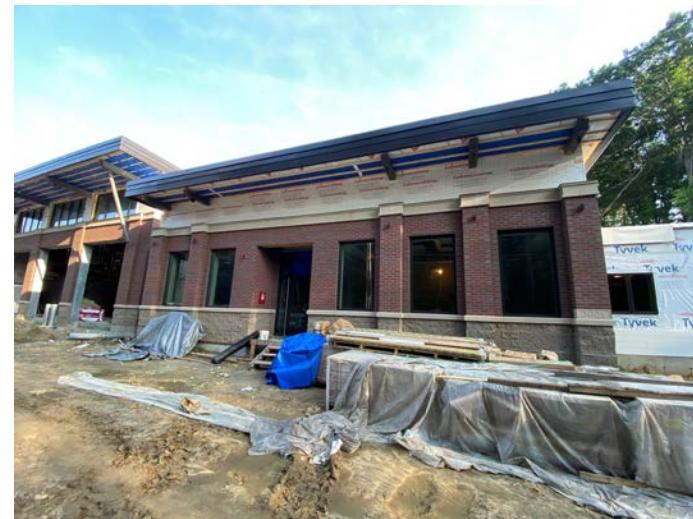
Overview of main entrance

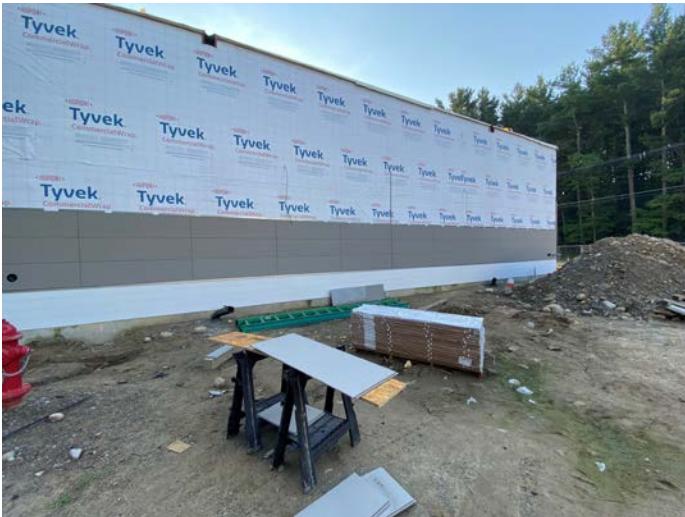
Overview of west side of building

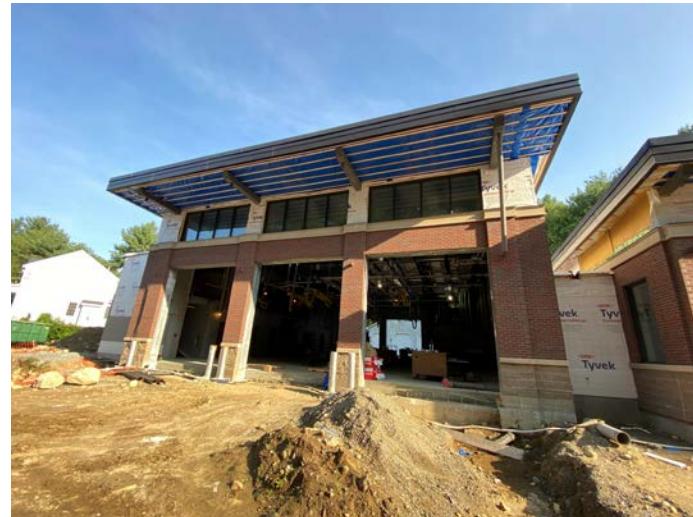
Overview of apparatus bay south side

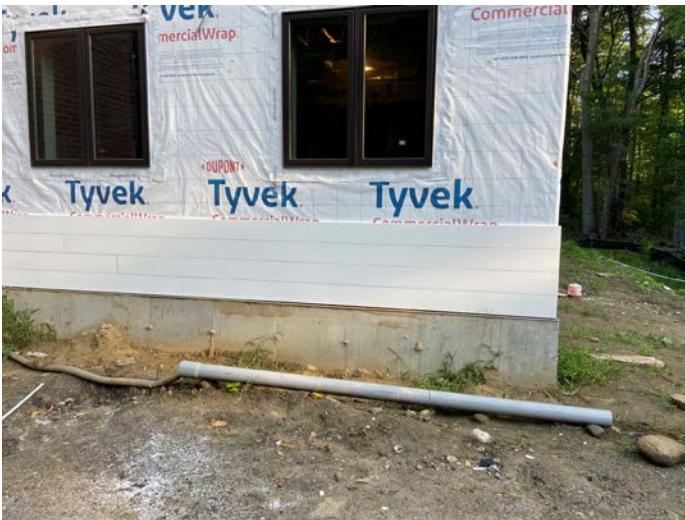
PVC siding on southeast side of building

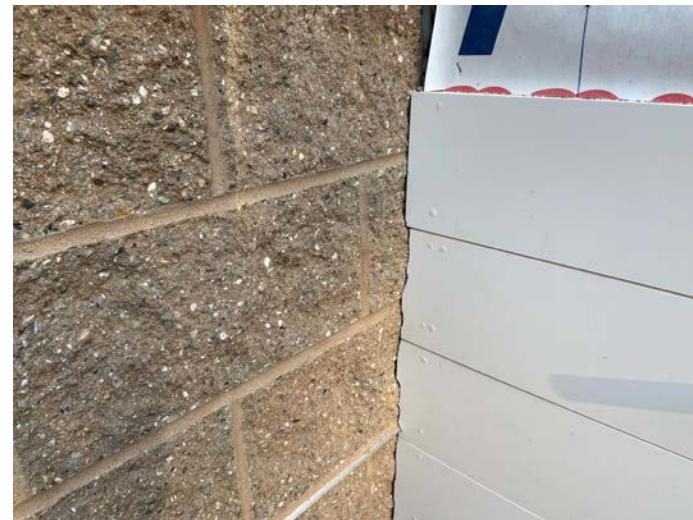
Typical PVC to cast stone interface

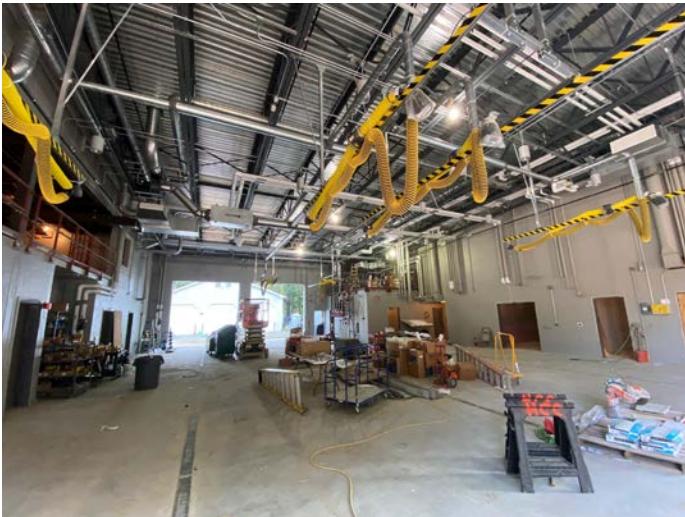
Overview of apparatus bay

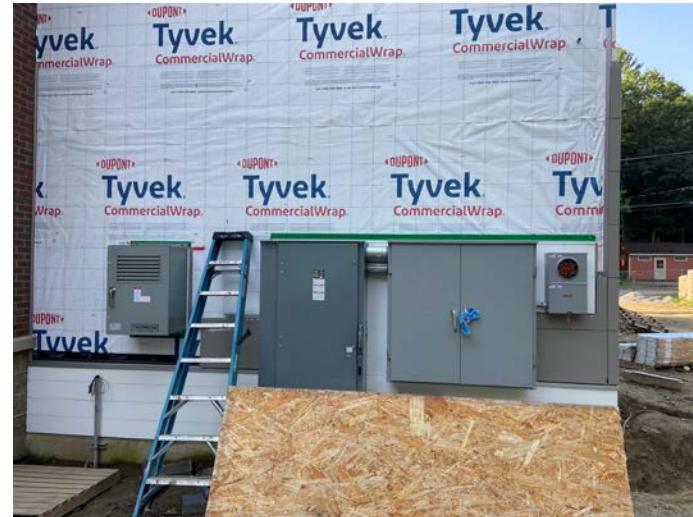
Exterior electrical cabinets and meter

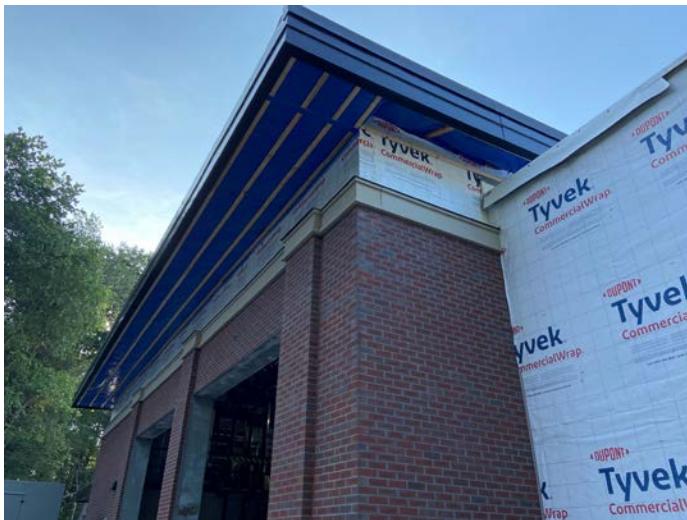
Typical vapor retarder installed at exterior soffits

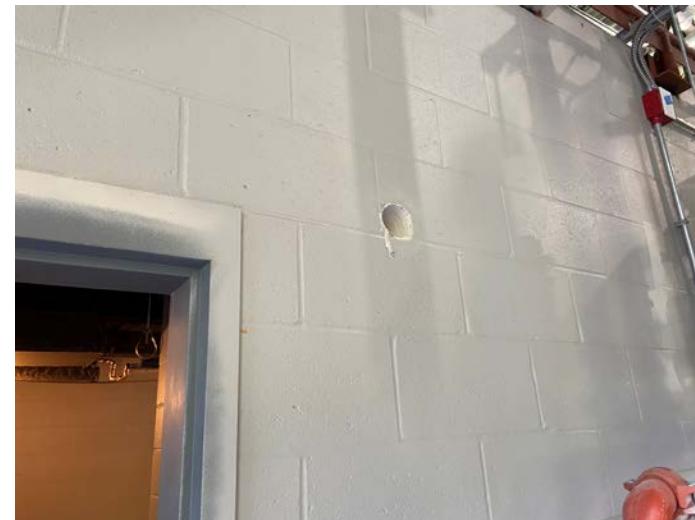
Hole cored through CMU wall for dirty laundry room HVAC condensate line

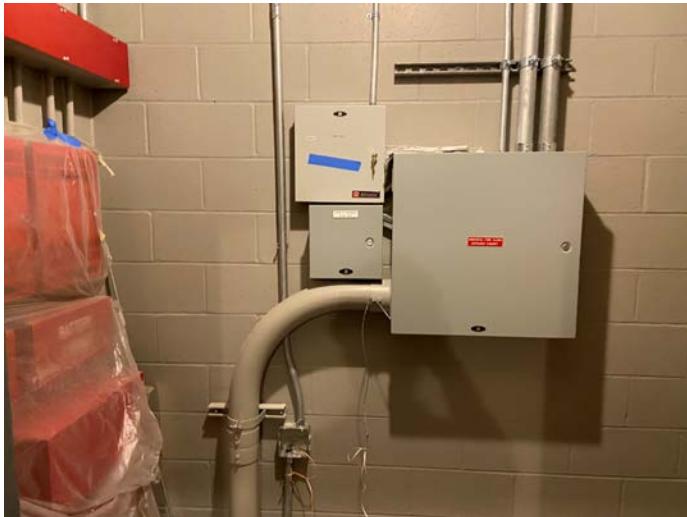
Fire alarm equipment installation in emergency electrical room

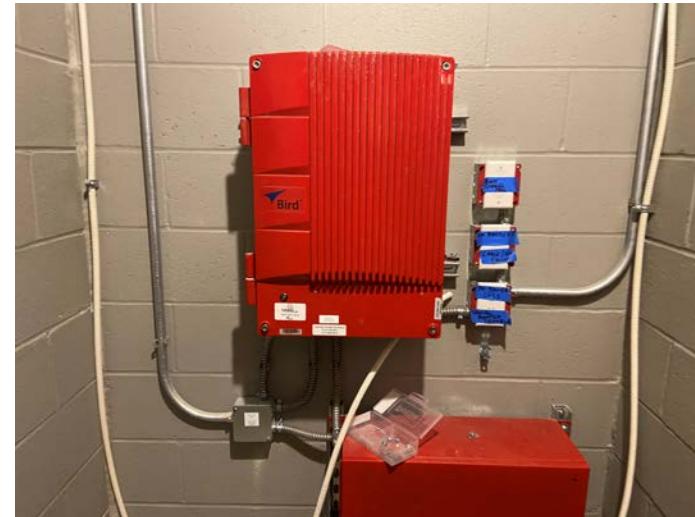
BDA equipment installation in emergency electrical room

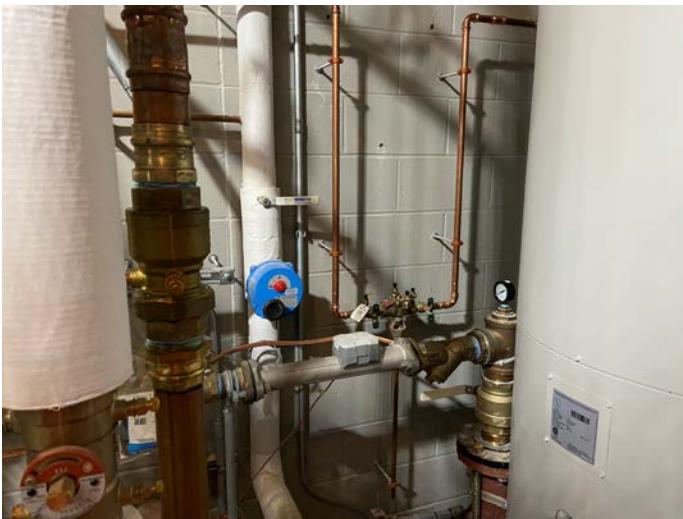
Backflow preventer in mechanical room relocated per Water District

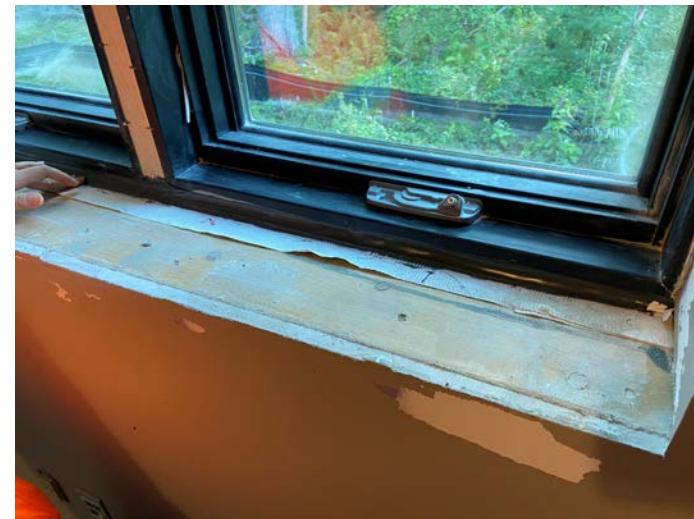
Interior joint sealant installed at bunk room windows

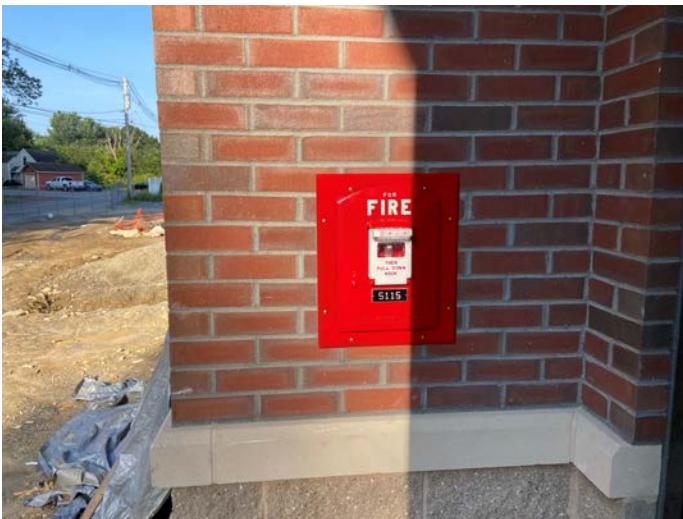
Fire alarm master box at main entrance

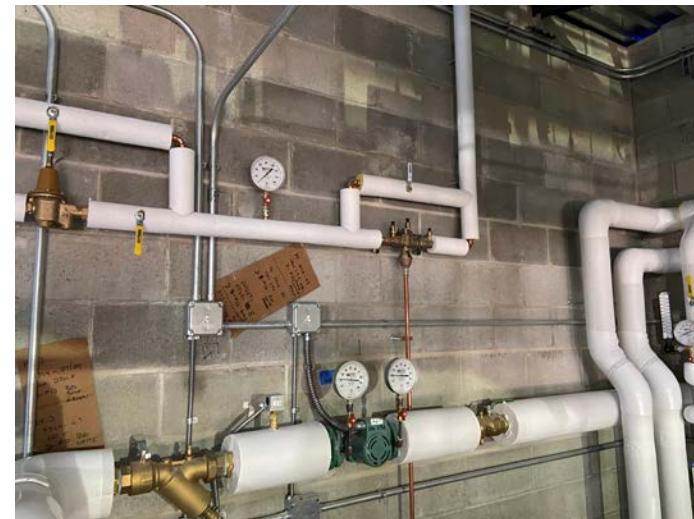
Backflow preventer at mechanical mezzanine to be relocated and bypass removed
