ACTON TOWN WIDE FACILITY & ELECTRIFICATION STUDY

10 YEAR MASTERPLAN

05 JULY 2023

PREPARED FOR
TOWN OF ACTON

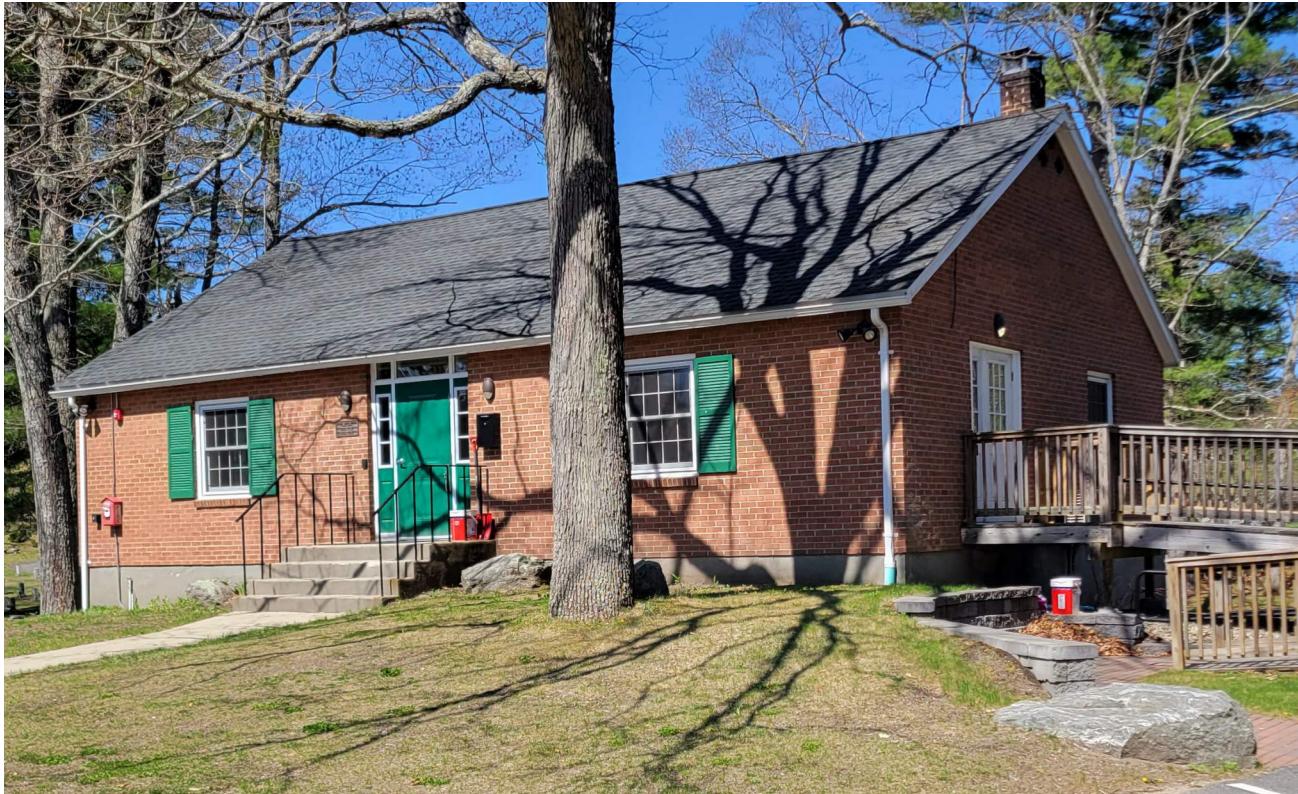
Kennedy Service Building

STRUCTURE	Parged masonry foundation walls, concrete floor deck. One story wood framing, wood truss and wood sheathing roof deck.
EXTERIOR WALLS	Brick veneer, stucco in rear of building, Some efflorescence found on rear of building at ground. Level of insulation unknown, assumed minimal if any.
EXTERIOR OPENINGS	Windows have been replaced with new IGU double hung units in 2018. Hollow metal exterior entrance doors at upper level, wood oversized utility doors at lower level.
ROOFING AND RAINWATER MANAGEMENT	3-tab asphalt shingle roof replaced 2012. Aluminum gutters and downspouts. Attic is insulated with batt. Appears to be in good condition.
STAIRS AND VERTICAL CIRCULATION	Wood tread stair to basement. Guardrail not suitable for public use and missing from exterior wall side. Door at foot of stair is in path of travel. Last tread is a tripping hazard.
INTERIORS AND FINISHES	Primarily painted CMU and concrete on lower level, painted GWB on upper level. Exposed concrete floor on lower level, wood look composite on upper level in good condition. Ceiling is painted GWB.

The building has undergone a relatively recent refresh of the interior. However, the mechanical system is still fossil fuel based, and therefore additional investment will be necessary to achieve the goal of all buildings being electrified by 2030.

The electrification recommendations should be able to be implemented with relatively little impact on the recent first floor renovation if the new air handlers are located high in the garage ceiling, similar to where the furnace is now.

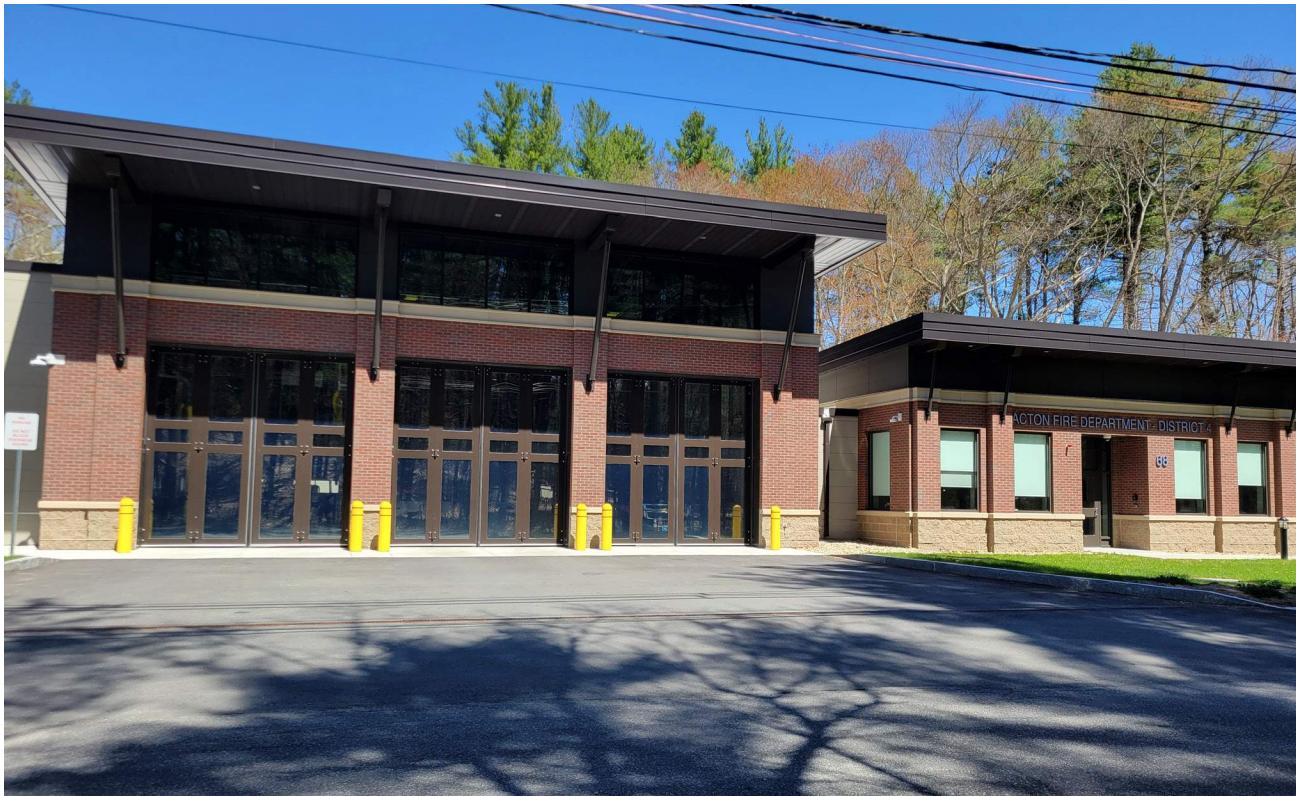
North Fire Station

STRUCTURE	Concrete slab on grade, steel and masonry, steel roof joists & deck
EXTERIOR WALLS	Mix of brick veneer, split face CMU water table and fiber cement panel, CVPC tongue and groove water table. 3" Rigid insulation on CMU loadbearing back up walls, stud walls have additional mineral wool batt in the stud cavity.
EXTERIOR OPENINGS	Hinged bifold oversized glass bay doors, overhead metal garage doors. Hollow metal passenger doors. Fiberglass punched windows, IGUs.
ROOFING AND RAINWATER MANAGEMENT	PVC roof membrane on 1/2" high density cover board on rigid insulation, some tapered on flat deck, some flat on sloped deck. Brand new in excellent condition. Water is managed through a series of scuppers, gutters, and downspouts.
STAIRS AND VERTICAL CIRCULATION	Larger mezzanine level accessed via metal pan stairs with concrete treads only, smaller mezzanine level is accessed via ladder only. All spaces in these mezzanine levels are mechanical/back of house spaces, no elevator or lift has been provided.

HVAC	The mechanical system serves it's intended purpose and is in new condition. The building is already fossil fuel free.
ACCESSIBILITY	This building was moved & renovated after the latest round of Title 2 assessments was completed, therefore there are no previous reports available to review. From general site observations (No measurements were taken) the buildings are generally compliant with the exception of the basement spaces.
CODE CONSIDERATIONS	This building is practically new, therefore it is assumed that it is compliant with all current codes. The structural capacity of the roof was also already reinforced for the additional snow loads to be imposed by the future planned canopy as part of the construction phase. The building is currently smaller than the State of Massachusetts MGL Ch. 148 Sec. 26G threshold for requiring sprinklers throughout the building.

APPEARANCE	Evidence of graffiti removal- frequent painting may be necessary to maintain the appearance of buildings.
HISTORIC DISTRICT CONSIDERATIONS	This building is not in a Historic District nor is it on the National Register.

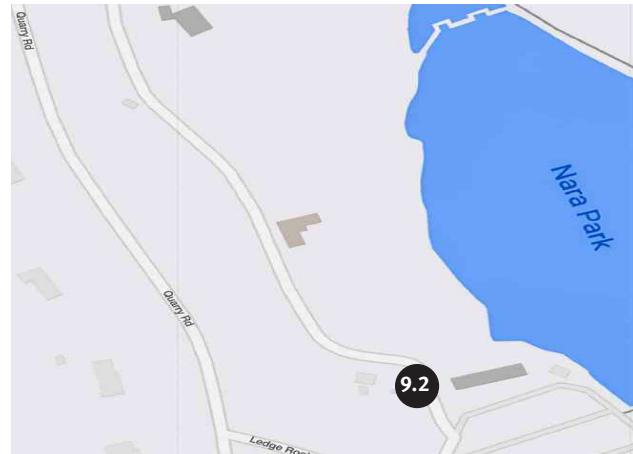
STRUCTURE	Concrete slab-on-grade, concrete piers, masonry piers, timber construction. Bathhouse is CMU construction.
EXTERIOR WALLS	Wood ship-lap siding and prefinished CMU block. No insulation.
EXTERIOR OPENINGS	Single pane wood frame windows and doors.
ROOFING AND RAINWATER MANAGEMENT	Wood shingle roofing, shakes appear to be in poor condition. No rainwater management.
STAIRS AND VERTICAL CIRCULATION	No vertical circulation, ground level only
INTERIORS AND FINISHES	Unfinished wood slat floors, unfinished concrete floors, unfinished cedar walls and ceilings. Bathhouse has unfinished/prefinished CMU
SEALANTS AND CAULKING	CMU joints appeared to be in good condition. Window sealants also appeared to be in good condition.
PLUMBING	<p>Water Service: 1" Water Service</p> <p>Utilities: The water service is connected to a centralized water system for the town. The sanitary waste system is connected to a septic system located on site. All utilities appear to be original to the building and appear to be in good condition.</p> <p>Water Heating Systems: There is point of use Electric Water Heaters throughout the facility. These heaters appear to be original to the building and be in good condition but are nearing the end of their useful life.</p> <p>Plumbing Fixtures: Fixtures in Bathrooms are vitreous China with Manual Flush Valves for Toilets and Urinals, Eye Wash Stations and Hand Wash Stations are Stainless Steel with Manual Operation. All fixtures appear to be original to the building and in good working condition.</p> <p>Piping System: The supply piping that was observed was copper. The drainage piping that was observed was cast iron. All piping appears to be original to the building and in good working condition.</p>

HEATING	The building is heated through the use of Electric Heaters. These heaters appear to be original to the building and in fair condition.
COOLING	There is no cooling.
VENTILATION	<p>Ventilation is achieved via natural ventilation through the use of operable windows.</p> <p>Exhaust System: There is localized exhaust systems for the bathrooms along with the serving area. These fans appear to be original to the building and in fair condition.</p>
CONTROLS	The existing heating equipment and exhaust fan are controlled by stand-alone electric controls.

HVAC	The mechanical system is minimal, with heating only. The building is seasonal in nature with limited winter time use. Building is already electrified.
ACCESSIBILITY	Appears to be mostly compliant. The most recent Title II assessment identified a number of relatively minor accessibility barriers associated with the parking lot and exterior route, the restrooms, signage, and the counters. It is anticipated that the scope of recommendations would at least trigger the \$100,000 threshold for upgrades to the entrance, toilet rooms, drinking fountains, and public telephone as applicable.
CODE CONSIDERATIONS	It is not anticipated that the scope of work would trigger major code requirements, other than correcting accessibility deficiencies. The building is currently smaller than the State of Massachusetts MGL Ch. 148 Sec. 26G threshold for requiring sprinklers throughout the building.
APPEARANCE	The building is generally in good condition, with the exception of the roof.

ELEMENT TITLE	RECOMMENDATIONS	PRICE ESTIMATE	PRIORITY
Steep Slope Roofing	New sheathing, and standing seam metal roof	\$480,000	1
Domestic Water Equipment	Replace electric point of use domestic water heaters	\$18,000	1
Priority 1 Total	2	\$498,000	
Interiors	Refresh of restrooms: paint toilet partitions, insulate any exposed hot water piping, correct (16) accessibility barriers associated with the restrooms and mounting locations	\$22,500	3
Wall Finishes	Refinish all walls	\$33,000	3
Interior Specialties	Correct (2) accessibility barriers associated with counter heights	\$6,000	3
Information Specialties	Provide code signage to correct (2) accessibility barriers	\$450	3
Site	Correct (13) priority 1 accessibility barriers associated with the exterior accessible route and parking spaces	\$7,500	3
Priority 3 Total	5	\$69,450	
HVAC	The building heating is currently electric. Electric heating and exhaust fans appear to be in fair condition and should have several years of useful remaining life. Replace electric heating and exhaust fans within 5-10 year range.	\$115,000	4

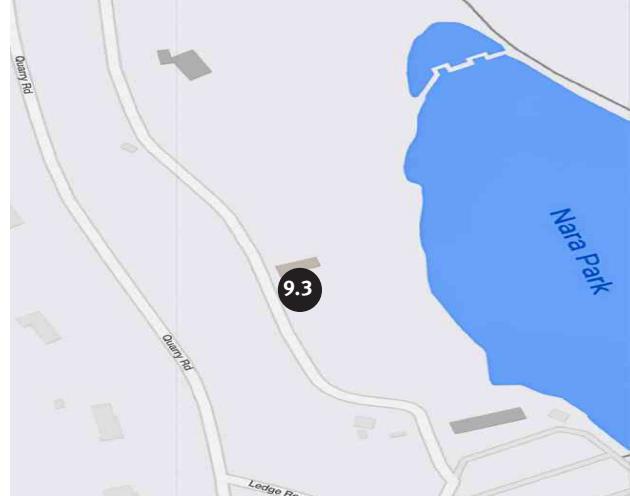
NARA Park Picnic Pavilion

STRUCTURE	Concrete slab-on-grade, concrete piers, masonry piers, timber construction
EXTERIOR WALLS	Open-air pavilion, with wood storage shed.
EXTERIOR OPENINGS	No windows, (2) single wood doors in storage shed. Door hardware needs maintenance and eventually to be replaced.
ROOFING AND RAINWATER MANAGEMENT	Standing seam metal roof. No rainwater management.
STAIRS AND VERTICAL CIRCULATION	No vertical circulation, one level only
INTERIORS AND FINISHES	Unfinished concrete floor and wood deck tiles, wood unfinished.
SEALANTS AND CAULKING	Stone piers joints appeared in good condition. Some caps were missing/needed repair. No other sealants observed.
PLUMBING	Water Service: There is a water meter located in a pit outside the Pavilion. There is 1" Pex water line from that meter that is capped in the Pavilion for future use and this also feeds a hose bib in the Pavilion. This piping appears to be new and in good condition.

CODE CONSIDERATIONS	It is not anticipated that these recommendations would trigger any code requirements. Structure is not a thermally conditioned space, therefore roofing project does not need to comply with the energy code.

APPEARANCE	The structure is in good condition and the appearance is picturesque. Regular cleaning and maintenance should maintain this good appearance.
HISTORIC DISTRICT CONSIDERATIONS	This structure is not in a Historic District or on the National Register.

ELEMENT TITLE	RECOMMENDATIONS	PRICE ESTIMATE	PRIORITY
Roof Structural Frame	Repair stone caps on piers	\$2,850	2
Exterior Entrance	New door & hardware on storage shed	\$3,750	2
Doors			
Priority 2 Total	2	\$6,600	
Lighting	Replace exterior lighting. Four kinds: strips, decorative pendants, downlights in piers, and flood security lights	\$37,500	4
Wall Painting and Coating	Refinish wood framing	\$36,000	4
Priority 4 Total	2	\$73,500	
Steep Slope Roofing	Repair/replace standing seam metal roof in 16 years	\$292,500	5
Priority 5 Total	1	\$292,500	
Grand Total	5	\$372,600

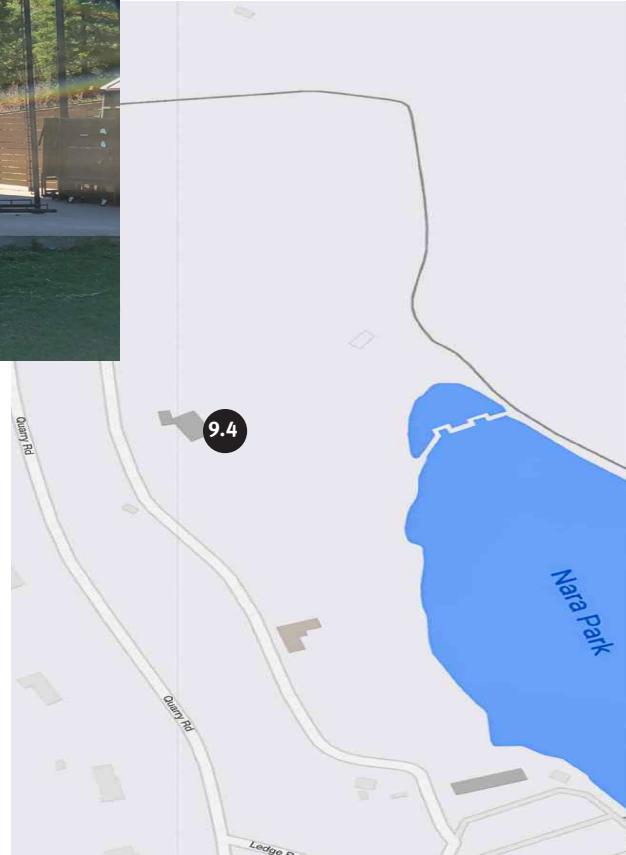
NARA Park Amphitheater & Snack Bar

STRUCTURE	Concrete slab-on-grade, concrete piers, steel pipe columns, timber construction, wood sheds
EXTERIOR WALLS	Open-air pavilion, wood fence along rear is in good condition. Two small uninsulated wood sheds have been placed on the “back of house” concrete pad.
EXTERIOR OPENINGS	Open serving window with wood cover, wood double doors to access sheds.
ROOFING AND RAINWATER MANAGEMENT	Wood shingles, appear beyond useful life. Some leaders are in disrepair. Sheds have a standing seam metal roof that appears in good condition.
STAIRS AND VERTICAL CIRCULATION	No vertical circulation
INTERIORS AND FINISHES	No interior finishes, trellis wall made of unfinished wood.
SEALANTS AND CAULKING	No visible sealants
PLUMBING	There is no Plumbing System in the building.
VENTILATION	Natural ventilation only
FIRE PROTECTION	There is no Fire Protection Systems in the building.
ELECTRICAL	<p>Electrical Service:</p> <ul style="list-style-type: none"> - Feed from pad-mount transformer - 120/240 Volt - 1Phase - 3Wire - 200Amp - Direct Metered <p>Electrical Distribution:</p> <ul style="list-style-type: none"> - Circuit Breaker type Panelboard with Main Circuit Breaker. - General Power - distributed by 15A and 20A straight blade duplex receptacles. <p>Interior and Exterior Lighting:</p> <ul style="list-style-type: none"> - Buildings- Surface mounted 1x4 wraparound luminaires with (2) T8 fluorescent lamps. - Covered Walkway - (6) flush inground luminaires. <p>Lighting Controls:</p> <ul style="list-style-type: none"> - Interior building lighting is controlled by toggle type wall switches - Exterior Amphitheater lighting is controlled by circuit breaker. <p>Raceway and Wiring:</p> <ul style="list-style-type: none"> - Exterior - Conduit and conductors - Panel Feeder - Conduit and conductors - Interior Branch Circuits - both AC and NM type wire.

ACCESSIBILITY	Appears to be fully compliant. Does not appear to have been included in most recent Title II accessibility review.
CODE CONSIDERATIONS	It is not anticipated that these recommendations would trigger any code requirements. Structure is not a thermally conditioned space, therefore roofing project does not need to comply with the energy code.
APPEARANCE	The structure is in generally good condition, except the roof over the stage.
HISTORIC DISTRICT CONSIDERATIONS	This structure is not in a Historic District or on the National Register.

ELEMENT TITLE	RECOMMENDATIONS	PRICE ESTIMATE	PRIORITY
Rainwater Management	Install/replace metal (non-copper) downspouts	\$10,500	1
Lighting	Install emergency lighting system	\$7,500	1
Steep Slope Roofing	New sheathing, and standing seam metal roof over stage area	\$190,500	1
Priority 1 Total	3	\$208,500	
Exterior Walls, Painting and Coating	Repaint storage shed	\$7,500	2
Priority 2 Total	1	\$7,500	
Flooring Treatment	Refinish/repaint floor	\$36,000	3
Priority 3 Total	1	\$36,000	
Lighting	Install/replace interior fluorescent lighting with LED	\$36,000	4
Priority 4 Total	1	\$36,000	
Grand Total	6	\$288,000
